The Management of Mitigation and Reconstruction for the Hazardous Catchment Areas Caused by the 2009 Typhoon Morakot

Wang Chin-Lun*, Chung, Chi-Rong*, Shieh Chjeng-Lun**, Lai Wen-Chi**
Soil and Water Conservation Bureau, Council of Agriculture, Executive Yuan, Taiwan *
Disaster Prevention Research Center, National Cheng Kung University, Taiwan**

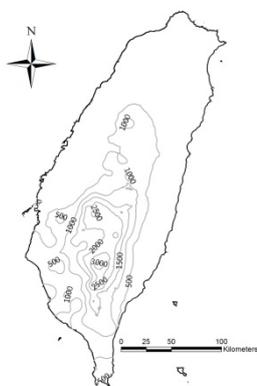
Fig. 1 Isohyets of Taiwan during Typhoon Morakot. Isohyets are in mm depth of total rainfall.

et al. (2009), the characteristics of the rainfall of Typhoon Morakot are long-duration, large-extent, and high-intensity. For example, the incremental and cumulative rainfall hyetographs (Fig. 1) at the rain gauge Fenchihu show that the duration of the observed rainfall is 118 hours and the cumulative rainfall depth is 2841.5 mm. The greatest 1-hour rainfall intensity is 109.5mm/hour.

The isohyets of cumulative rainfall depth for Taiwan during Typhoon Morakot are depicted in Fig. 1. From Fig. 3, it can be found that the heavy rainfall covered whole Taiwan during Typhoon Morakot. Therefore, it is said that one characteristic of the rainfall of Typhoon Morakot is large-extent.

Storm centers can be observed in the southern area of Taiwan from Fig. 1. The locations of the storm centers have strong connections with the disasters. Most of severe disasters, including landslides and landslide dams, occurred surrounding the storm centers. Flood occurred in the downstream areas of the storm centers as well.

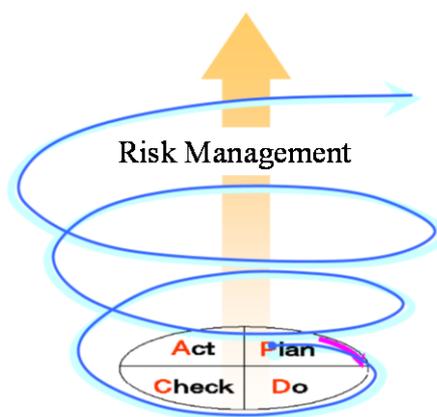
Fig. 10 The PDCA cycle for risk management (MLIT, Transport and Tourism Japan, 2008).

Through the combination of hardware and software disaster prevention measures (Debris flow monitoring, investigation, dredging and disasters control works). Target on conservation of watershed, protection of water resources and hazard mitigation. Strategy of watershed conservation and hazard mitigation should be done by structural engineering and risk management methods. Through the PDCA cycle (Walter A. Shewhart, 1980), Plan→Do→Check→Act continue to improve the techniques of the risk management.
