# PLAN DESIGN AND CONSTRUCTION MANAGEMENT STUDY OF KAO-133 HIGHWAY AFTER TYPHOON MORAKOT DISASTER

Chang-Ching GUAN\*, Cheng-Hsing JUAN\*, Cheng-Chang HSIEH\*, Tung-Hung TSAI\*  
CECI Engineering Consultants, Inc., Taiwan\*

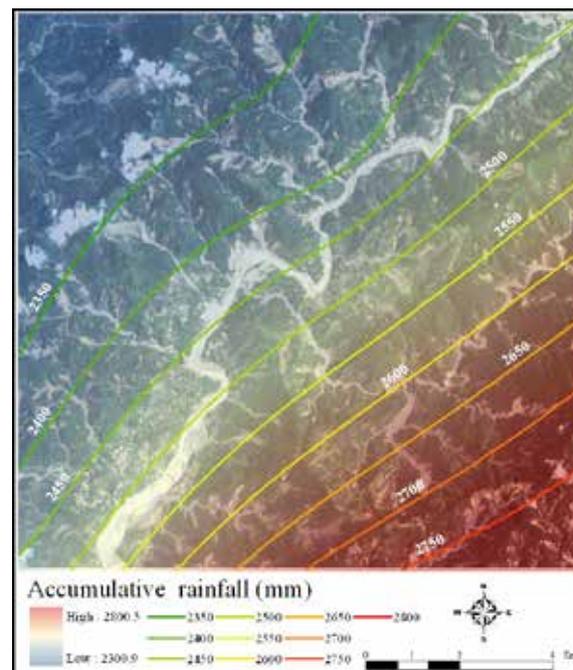
Fig.1 Rainfall record of Lawnon river basin

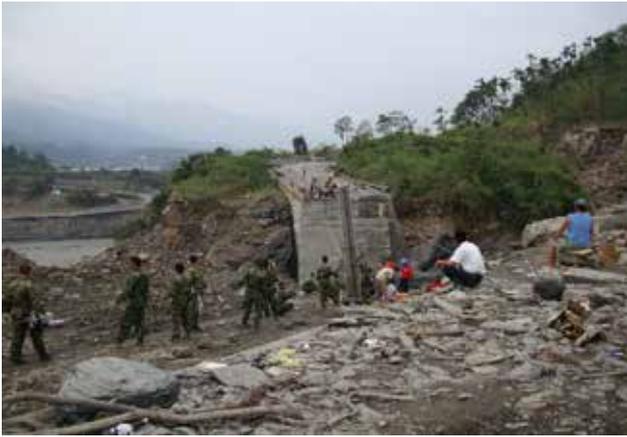
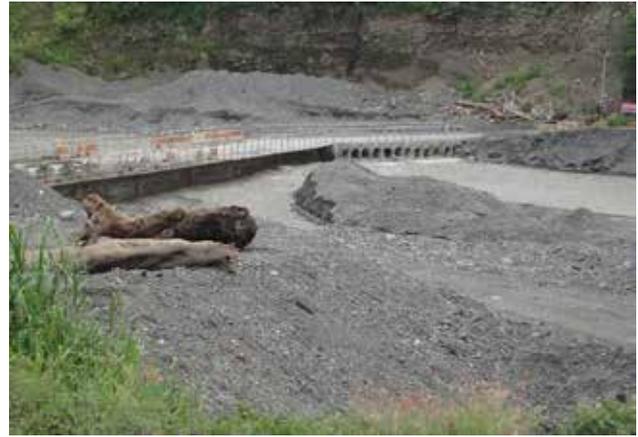
Fig.2 Bridges injured after Typhoon Morakot

Taiwan is an island with abundant rainfall. The torrential rainfall accompanied with typhoons frequently causes slope failures such as landslides and debris flows. Moreover, earthquakes also degrade the slope stability. In early August of 2009, Typhoon Morakot attacked Taiwan, and caused significant loss of lives and property. Accompanied with the typhoon movement, the southwest monsoon brought torrential rains primarily concentrated in the southern Taiwan. The accumulative rainfall in Lawnon River basin was up to 2500 mm, as shown in Fig. 1. The Lawnon River basins suffered from the severest slope disasters during this event. It also led to various types of damage to the infrastructures and transportation systems, as shown in Fig. 2-3.

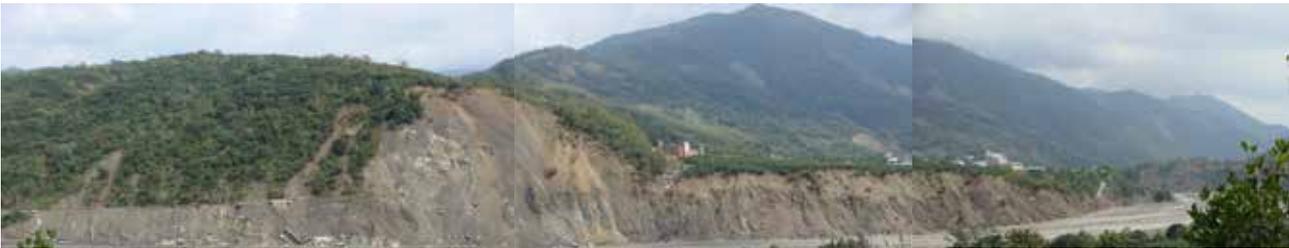
Fig.3 Road damaged after Typhoon Morakot

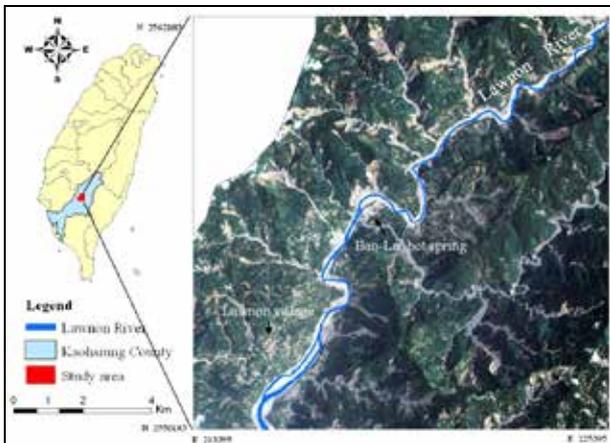
Fig. 4 Domain of study area

The study area is located in the upstream of Lawnon River Basin, around the Bao-Lai hot spring area with ambit of 130.4 km<sup>2</sup>(Figure 4). The Bao-Lai hot spring region, the most populous area in the neighborhood, suffered a severe flood and landslides during Typhoon Morakot. Geology in the study contains four rock formations, including Tangenshan Sandstone (Tn), Changchikeng Fm.(Cc), Chaujou Fm.(Co), and Mt. Bilu Fm.(Ep). Among them, Tangenshan Sandstone (Tn) and Changchikeng Fm.(Cc) belong to sedimentary rock areas, and Chaujou Fm.(Co) and Mt. Bilu Fm.(Ep) belong to metamorphic rock areas. The Lawnon Fault is the boundary line between the sedimentary rock and the metamorphic rock. In addition, there are many hot spring sites within the study area, mostly located in Chaujou Fm.(Co).

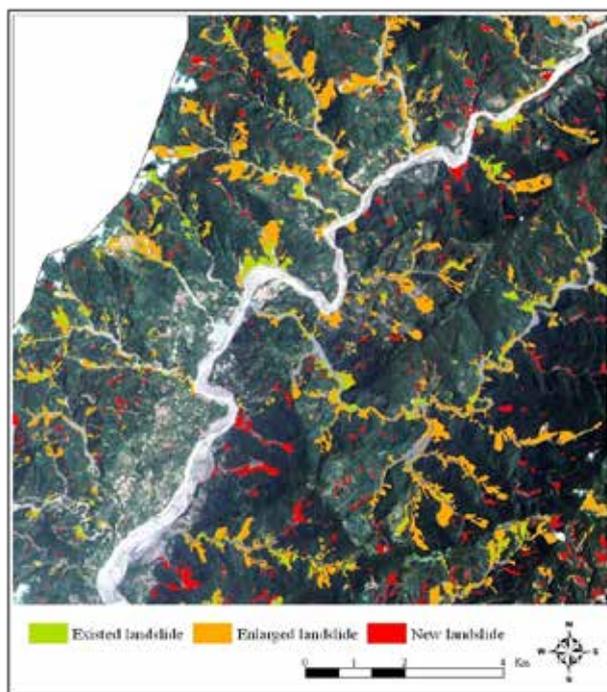
Fig. 5 Classification and distribution of landslides (after Typhoon Morakot)

To better determine the characteristics, landslides recognized in each satellite image were firstly classified into existing landslides and incremental landslides. The difference in images before and after a storm event, showing landslides caused by a specific event between images, indicates incremental landslides. Existing landslides represent overlap in landslide images before and after the storm event. In order to assess how many landslides are expanded from existing ones, incremental landslides are further classified into new landslides and enlarged landslides. New landslides can only be observed in the new image, and enlarged landslides have expanded from existing landslides in the previous image. Figure 5 illustrates the distributions of existing landslides, enlarged landslides and new landslides caused by rainfall during Typhoon Morakot.

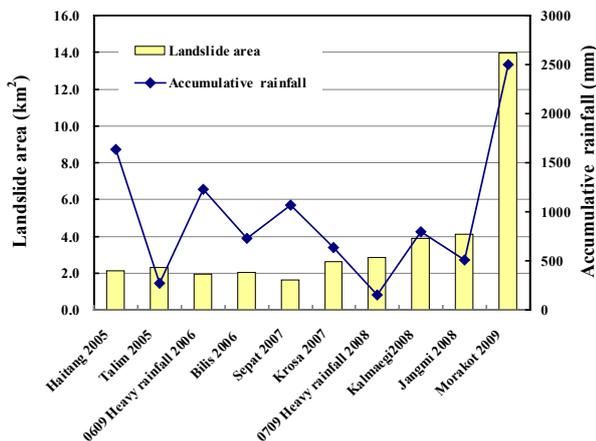
Fig. 6 Landslide ratio variation in 10 rainfall events

Rainfall, especially from storms, is the dominant factor inducing landslides. Combining the accumulative rainfall data and landslide ratio of each event (Fig. 6), landslide regions of the study area are observably growing in the past five years, though some small recovery appeared between two

consecutive events. Herein landslide ratio is expressed as a percentage, yielded from total landslide area divided by overall area within a specific geological zone. Before 2008, the rainfall variation within the study area was not obvious, so the landslide areas variation was not significant. The extreme rainfall brought by Typhoon Morakot remarkably increased the scale of landslides. It is evident that rainfall dominates the scale of landslides. Comparing rainfall data among events, Typhoon Morakot has the highest accumulative precipitation (2502mm on average), followed by Typhoon Haitang (1882mm). However, it is significant that the average landslide ratio induced by Typhoon Haitang was only 1.29%, much less than those induced by Typhoon Jangmi and Kalmaegi.

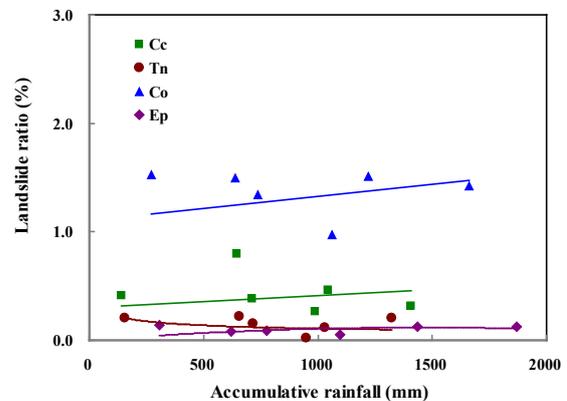
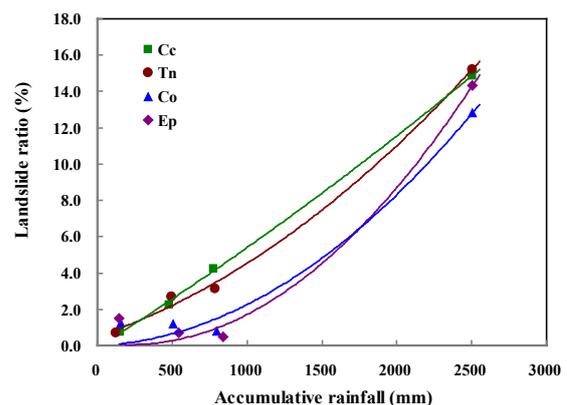
(a) Incremental landslide before 2008

(b) Incremental landslide after 2008

Fig. 7 Comparison of incremental landslide ratio

Figure 7 shows the variations of landslide ratio with respect to each geological zone, and the corresponded accumulative precipitation record is also plotted. The incremental landslide ratio of each geological zone generally remained below 2% before 2008 (Fig 7(a)). The landslides frequently occurred in formation Co. However, after the 2008 earthquake the landslide ratios of sedimentary formations (Cc and Tn) surpassed those of metamorphic rock areas (Co and Ep) (Fig 7(a)). Fig. 8 illustrates the variation of enlarged and new landslides with respect to different geological formations. No matter the lithology, the

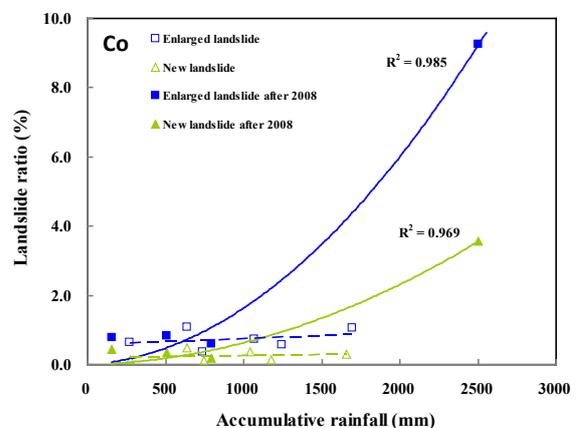
Fig. 8 Landslide ratio variation for enlarge and new landslides

failure ratios of enlarged landslides is larger than those of new landslides, which means most landslides came from regeneration and expansion of existing landslides. In other words, as a landslide occurs, it will precipitate subsequent failure nearby.

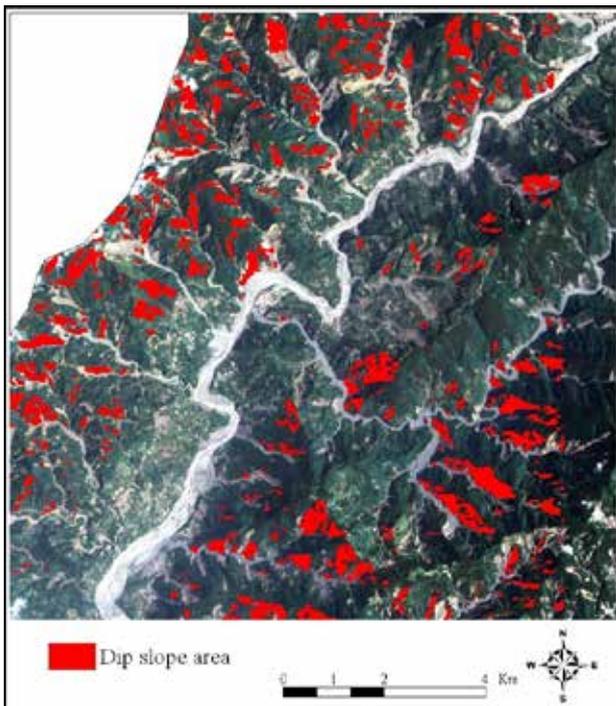
Fig. 9 Distribution of dip slope in study area

A dip slope means a topographic surface where the dip is consistent with that of the underlying strata. Dip slopes are commonly found in cuesta and vale topography. Usually, dip slopes are quite prone to landslides, due to the plane failure along persistent weak planes. In the Lawnon River Basin, dip-slope topography is commonly seen in the slope land. According to the definition of Central Geological Survey (CGS) of Taiwan, dip slopes are the slopes with difference of slope direction and dip direction of weak planes being less than 20 degrees. The distribution of dip slopes in the study area was digitized on the GIS platform as shown in Fig. 9. Figure 10 illustrates the variations of landslide ratios in the dip slope zone, and it indicates that dip slope areas indeed possess higher landslide ratios whether before or after the main earthquake in 2008.

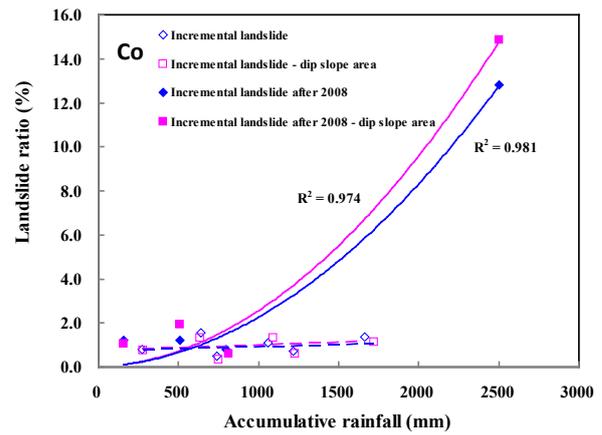
Fig. 10 Distribution of dip slope in study area

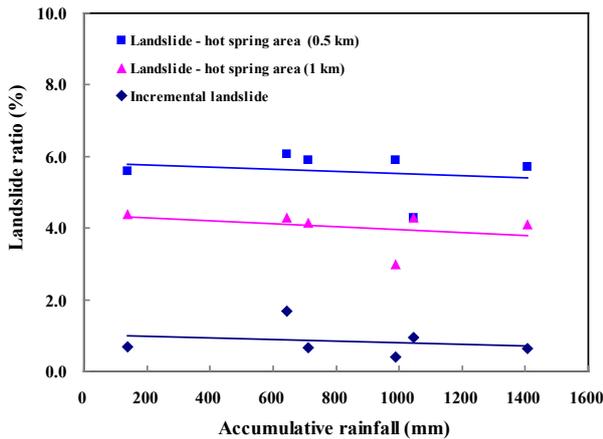
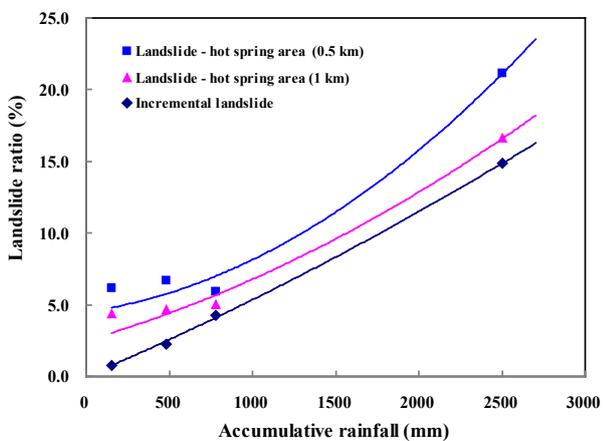
(a) Incremental landslide before 2008

(b) Incremental landslide after 2008

Fig. 11 Relationship of hot spring and incremental Landslide ratio

Lawnon River basin is famous for hot springs, and there are 10 hot spring sites in the neighborhood of the study area, mainly distributed in Chaujou (Co) formation. Most hot spring sites destroyed and covered by landslides and debris flows after Typhoon Morakot. Geologically speaking, the hot spring could be considered as a kind of geological fractured zone. Therefore, in this study hot spring zones are taken into consideration as landslide causative factors. Investigation of the relationship between landslide occurrence and hot spring locations was also conducted. Buffering analyses of 0.5 and 1 kilometers around the hot spring sites were carried out to study their landslide ratios as shown in Fig. 11. The result shows the regions within 0.5 km buffering distance around hot spring sites have higher landslide ratios than those within 1.0 km buffering zones, and far higher compared to those of the whole study area. The phenomenon is more pronounced after the earthquake in 2008. This observation shows the slopes located or close to hot spring sites are more prone to failure as triggered by rainfall.

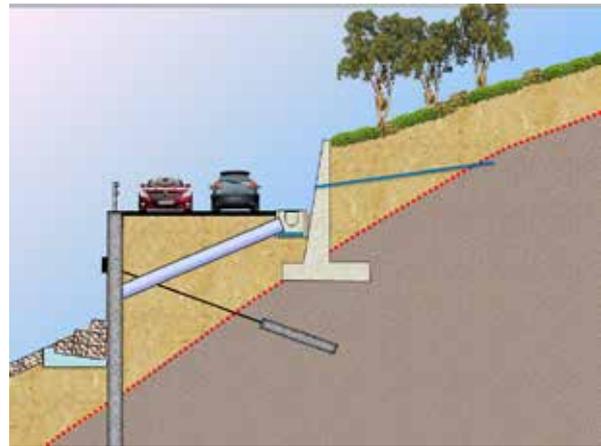
Fig. 12 The road rehabilitation schematic drawing

In view of the various disasters landslides, rockfalls, and debris flows exposed on the Kao-133 highway, the rehabilitation work mainly arranges piling or retaining wall to carry on the slope protection. In addition, sets the roadside box drain, drain tank, drain tunnel underneath the roadbed to release the rainfall current and avoid rainfall washout destruction. For blocking the potential glide stratification plane, it also disposes the pre-stressing ground anchor to fix the soil body, and establishes the monitor mechanism to examine the result as shown in Fig. 12.

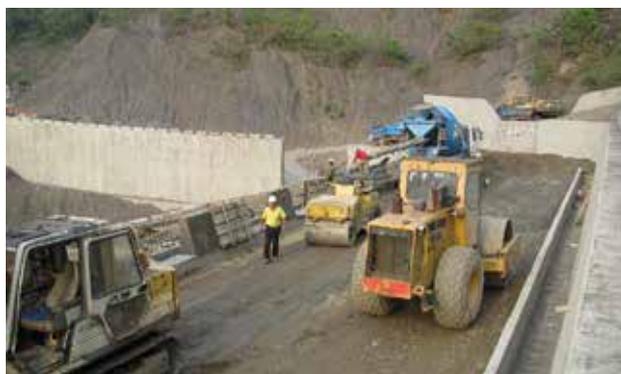
Fig. 13 Road rehabilitation construction

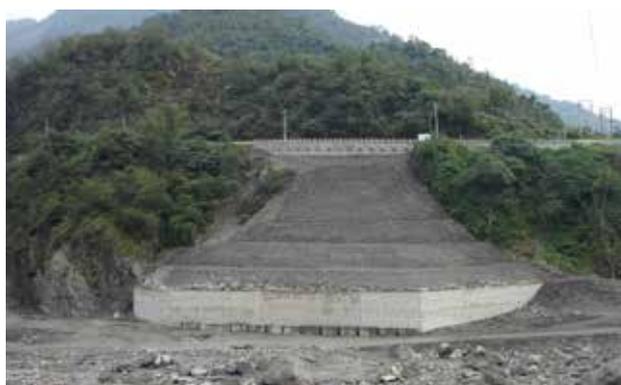
Fig. 14 The River bank protection works

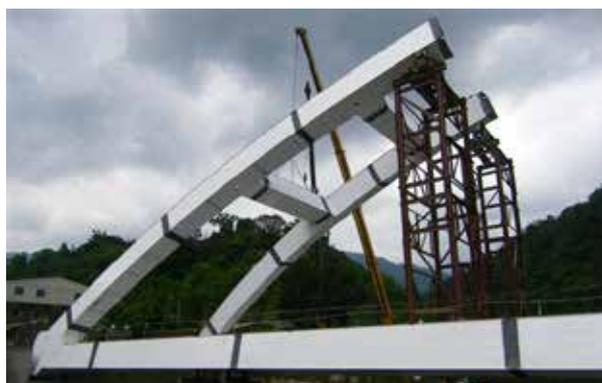
Fig. 15 The Bridge hosting work

1. Steel arched bridge is divided to small components to construct. It reduces the inconvenient of transportation, the hoisting capacity limit, and the construction uncertainty or risk in the mountain. Therefore, it promotes the rehabilitation project construction efficiency.
