## Post Typhoon Morakot Disaster Railway Reconstruction

Zhang Shuang Gui · Su Jie Ting  
Kaohsiung Engineering Section  
Taiwan Railway Administration

## Abstract

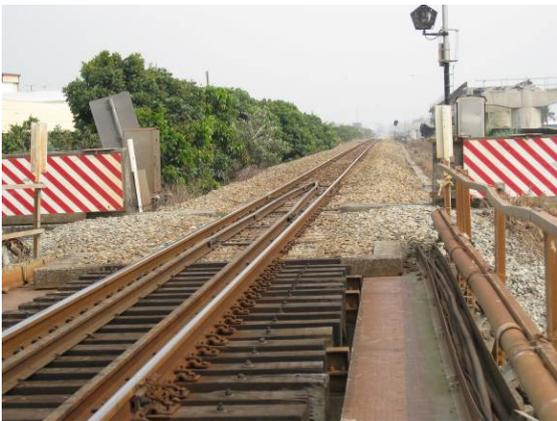
However, due to short of fund, it was unable to rebuilt in time and the south and north dykes had to reserve gaps (1.2 m high and 6 m wide) for the rail traffic (Fig. 4). In order to prevent flooding through the gaps during high water level of tidal period or invasion of typhoon with heavy rainfall, TRA built water gates to both gaps in Aug. 1995 as an emergency measure, so that the traffic safety may be maintained. As to the reconstruction project, Railway Reconstruction Bureau has contracted the project to contractors in serial to build a new bridge at about 12 m downstream of the existing bridge for a dual track most update standard electrified railway. (Fig. 5)

(Fig. 4) Old Water Gate of Linbian River Bridge Dyke Gap

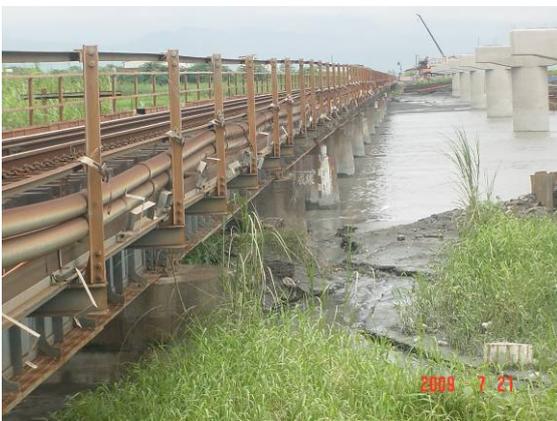
(Fig. 5) Bridge Pier of New Linbian River Bridge at the downstream side of old bridge.

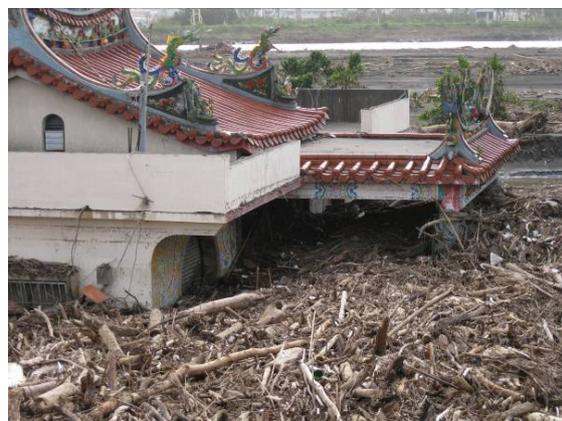
The heavy rainfall and huge flood brought by the Typhoon broke dikes of Linbian River and the town if literally submerged. The water level is as high as to the 2<sup>nd</sup> floor muddy water is flowing everywhere (Fig. 6) bodies of livestock and debris rushed along the streets. It was sad and amazing scene. The height of deposited soil in Linbian Railway Station was almost as high as the platform. (Fig. 7)

(Fig. 6) The water level is as high as to the 2<sup>nd</sup> floor and muddy water is flowing everywhere.

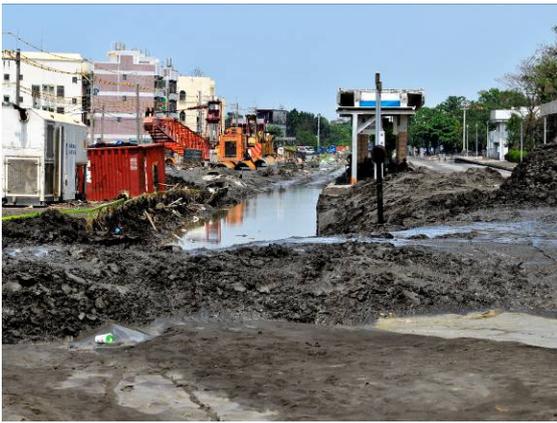
(Fig. 7) The height of deposited soil in Linbian Railway Station was almost as high as the platform.

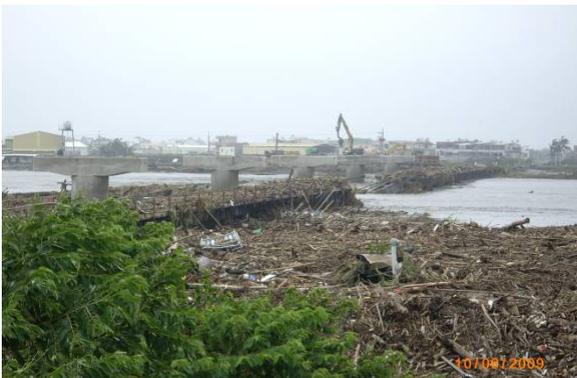
Due to the changes in the environment and terrain, the distance between surface of water flowing area and the bottom of Linbian River Railway Bridge was only 2 meter. With the instant heavy water flow, the cross section that allows for water to travel became insufficient, added with volume drifting wood (Fig. 8), furniture, bamboo rafts blocked by steel beam of the bridge. Under the giant thrust, the bridge was unable to sustain and 2 piers and 3 spans (P10, P11 & P12) were washed down (Fig. 9).

(Fig. 8) Volume driftwood brought up from upstream

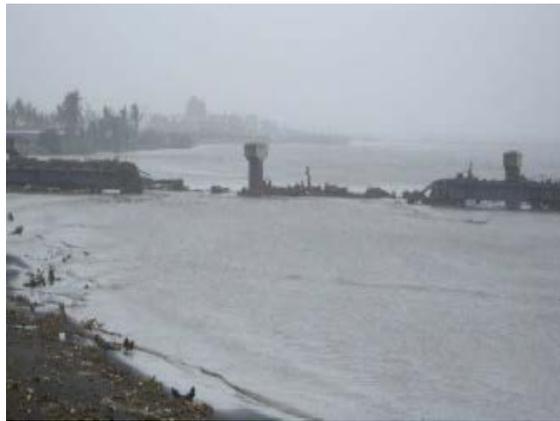
(Fig. 9) Washed off 2 piers and 3 spans (P10/11/12)

- (2) Restoration of Piers: This part included repair of damaged piers, refill of washed off road base, track laying and related electricity supply, electrical equipment and signal equipment. These jobs were awarded on August 13, 2009 and commenced the site construction. (Emergency joint survey was conducted on Aug. 9, 2009. Emergency Repair budget was established and contracted out on Aug. 14, 2009 and commenced on Aug. 15 with working period of 150 calendar days). The first phase 120 calendar days, aimed at resuming traffic on Dec. 30, 2009, and 30 calendar days for removing construction temporary bridge, restoration of pier No. 10, 11 and 12 and refilling of 120 meters road base (Fig. 12)

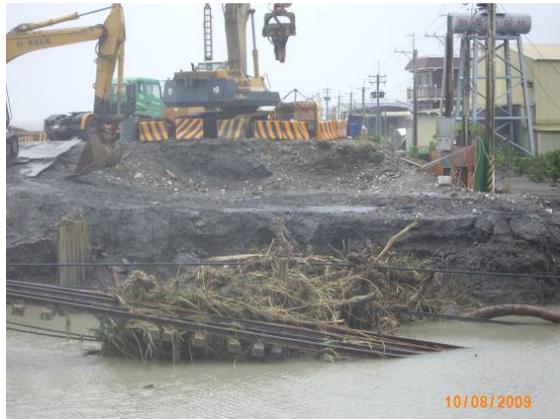
The upstream dike of north abutment was smashed for 30 meters and road base was flown away for 120 meters. In south side, the road base was covered by mud for 50 meters and the railway traffic was interrupted (Fig. 10).

(Fig.10) Damages to north abutment 、Washed off Road Base.

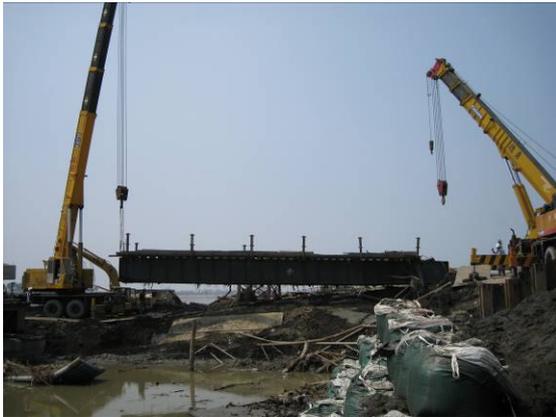
(Fig. 11) Bridge Steel Beams are totally lifted and moved away from site

- (1) Dismantle of Linbian River Railway Bridge Beams: After emergency joint survey of Aug. 27, to avoid added damages of any further invasion of typhoon, TRA removed all remaining 19 sets of steel beam of the bridge on

Sept. 7 to give increase space for water flow.

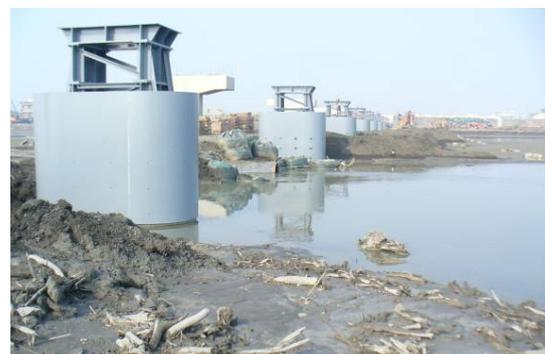
(Fig. 13) Adding 2 M high formed steel structure on top of pier and the RC piers are clad with steel plate and constrained with concrete.

- (3) Raising Pier Height: Since the Linbian River Railway Bridge is lower than the dikes and the New Linbian River Railway Bridge, which is under construction and is scheduled to open to traffic by Dec. 2011 and there are still 2 high water period, and in order to increase the traveling section and eliminate break, the bridge is planned to raise up for 2 meters, after taking the slope restriction of railroad, the safety of pier structure and the traffic facilities of the surrounding area. The Project had price negotiation on Sept. 14, 2009 and commenced site construction. [On Sept. 3, 2009, Ceci Engineering Consultant, Inc. Taiwan was commissioned to design the 2-M pier height raising. The emergency raising budget was passed and job was contracted out on Sept. 14 with commencement on Sept. 15. The construction period was allowed for 115 calendar days (Phase 1 is 85 calendar days, with Dec. 30, 2009 targeted for opening to traffic; Phase 2: 30 days for dismantle of construction temporary bridge). A 2-M high formed steel structure is added to the top of each pier (total 20 sets); each pier is clad with steel plate and restrained with concrete. (Fig. 13)

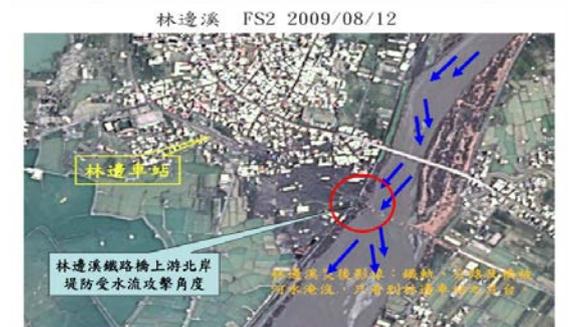
- 1) The rainfall on the day Typhoon Morakot hit Taiwan was indeed excessive and was in excess of 200-year frequency precipitation.
- 2) The S-curved flow of Linbian River offered different hitting angles and with the volume flood, along the river, from upstream to downstream, dikes were broken at many places. (Fig. 14)

(Fig. 14) Linbian River hitting angles.

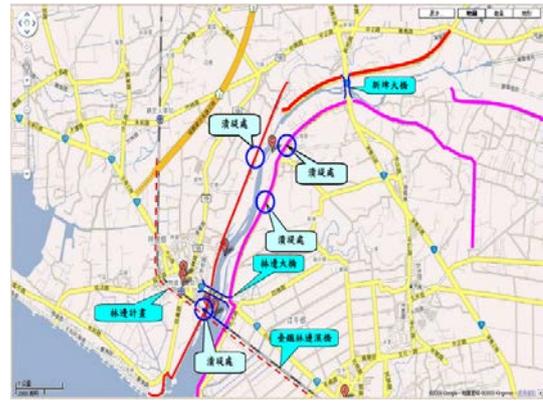
- (4) The lower part of the river water is characterized with S-shape flow and the attacking angles are curved and water flow rushes to and from. This is why the dikes were broken in many places both upstream and downstream and the break was not limited to the railway bridge. (Fig. 15)

(Fig. 15) Broken dikes along the river found after the disaster. (3 at upstream)

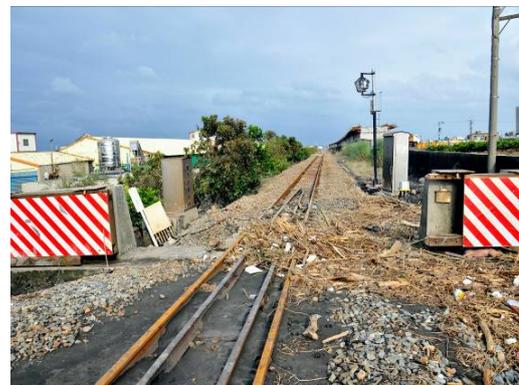
- (5) Height of dikes at both ends of Railway Bridge: The dike at the north side of Linbian River is about 0.9 m higher than the south side. Based on the fact that no effluent found at south bank, there should not be any in north Bank. (Fig.16)

(Fig. 16) South side gate was intact after the disaster due to deposit and stacking of drifting articles brought by the flood.

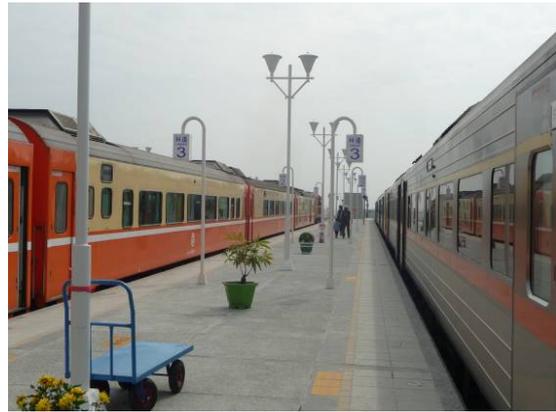
(Fig. 17) New Elevated Platform of Linbian Railway Station.

The new Linbian River Bridge built by 'Railway Reconstruction Bureau was finally open to service on January 10, 2012 and the escalated railway of Linbian line is completed for service, the old Linbian River Railway Steel Bridge will be dismantled and it is scheduled to completed in April, 2012, before the high water period of 2012. The interruption of railway service of Pintung Line and South Link Line due to closing of water gate during period of heavy rainfall will become history (Fig.

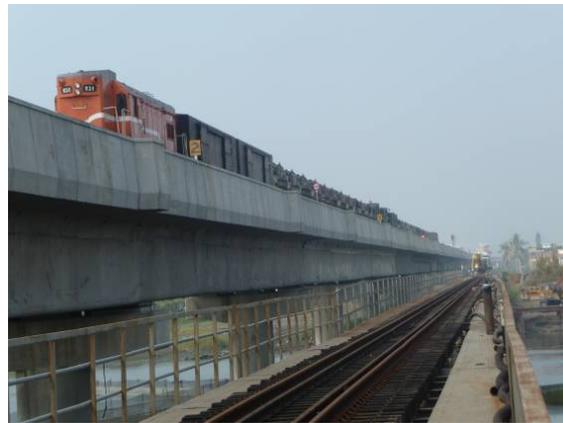
(Fig. 18) Train is switched to the elevated line.
