# Universal design concept of mitigation measures to tunnel structures in the case of fire

Yoshikazu OTA  
OTA Engineering

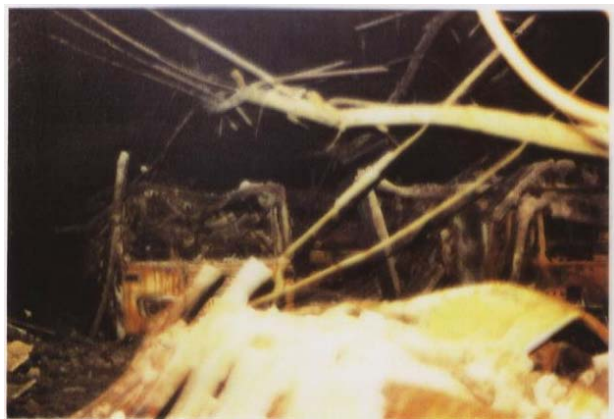
**1.2 Nihonzaka tunnel fire** (1979 Japan, photo by Dr T, Konda )

This picture presents totally collapsed tunnel inside and wrecked vehicles.

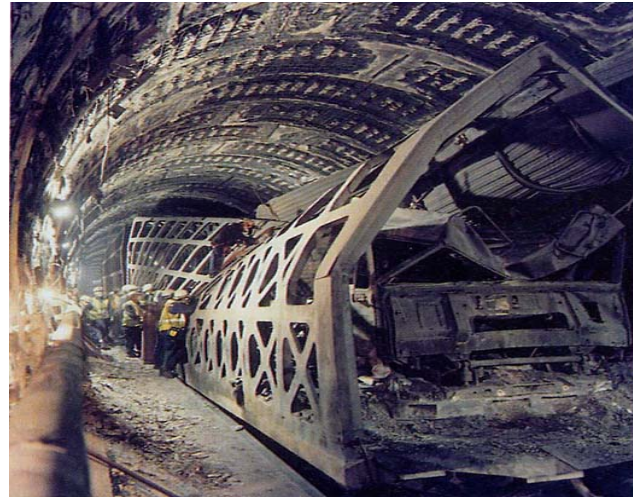
**1.3 Channel tunnel fire** (18/Nov 1996, 21/Aug 2006, 11/Sep 2008, UK-Fr. Photo by Trans Link Ltd, Geo front Research Institute 1998-1999).

rolling stock problem; it may have been due to arson of a heavy goods vehicle. It is estimated that the heart of the fire reached over than 1,000°C. Internal tunnel lining concrete was severely damaged at several hundred meters.

This picture presents the Peeling off of concrete segment and wrecked the rolling stock with burnt out vehicles (Euro Star Cargo) in Channel Tunnel at first fire of 18/sep, 1996.

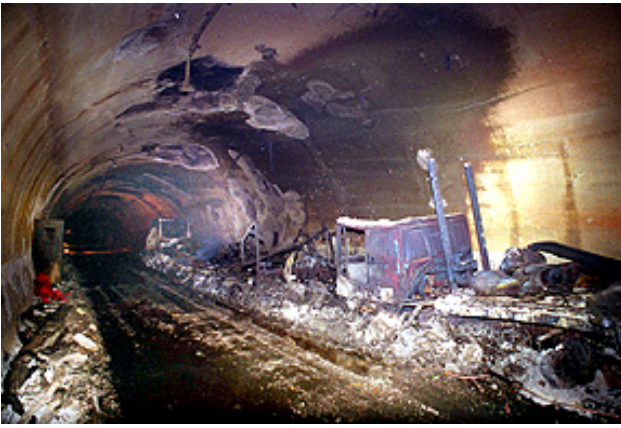
**1.4 Mont Blanc Tunnel Fire** (1999, France- Italy, photo by News, BBC, CO, UK)

On 24 March 1999, 39 people died. The bottom part of Belgian heavy truck was caught of fire by mechanical trouble. This truck caught fire in the tunnel at Italian side (near the boarder of France and Italy) and was carrying the flour and margarine. (these roading goods are not dangerous materials on the point of view of International reles of transportation through tunnels). 50 passengers were by the fire, most of drivers rolled up their windows and waited for rescue. The fire burned for 56 hours and temperatures reached over than 1,000 °C. As a results, 27 people died in their vehicles. And 10 person were died to trying to escape on foot, 12 person were survived. This picture presents just after the fire extinguished of Mont Blanc tunnel. Tunnel lining is peeled off the concrete lining. Maximum temperature reached to approximately 1,300°C.

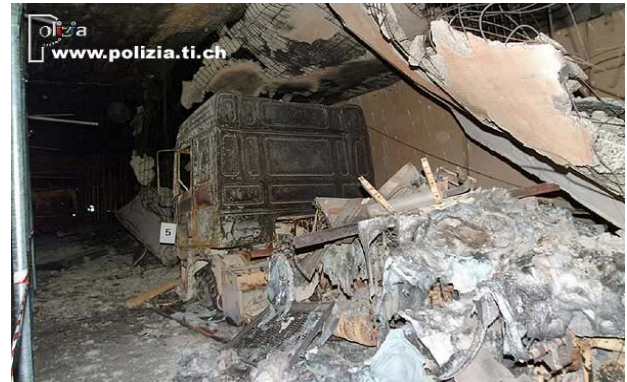
**1.5 Tauern Tunnel Fire** (1999 Austria, Kleine Zeitung, May 30, 1999)

This picture presents the collapsed concrete ceiling for fresh and exhaust duct by fire near the fire source.

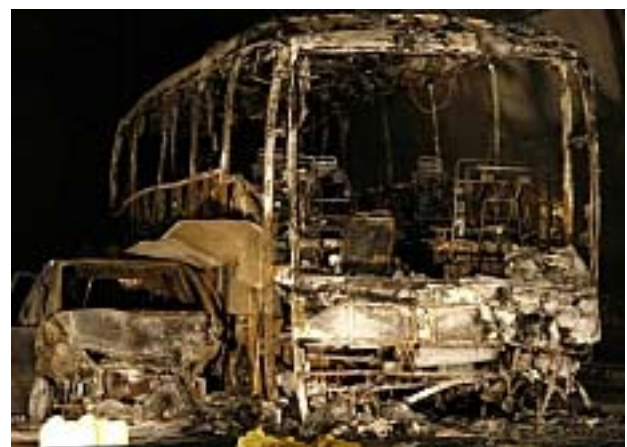
**1.6 Gotthard Tunnel fire** (1999 Switzerland)

This picture presents the totally destroyed vehicles and 9 persons were killed by fire but not serious structural damage. This tunnel was not equipped the sufficient smoke control system due to the short length in bi-directional traffic tunnel.

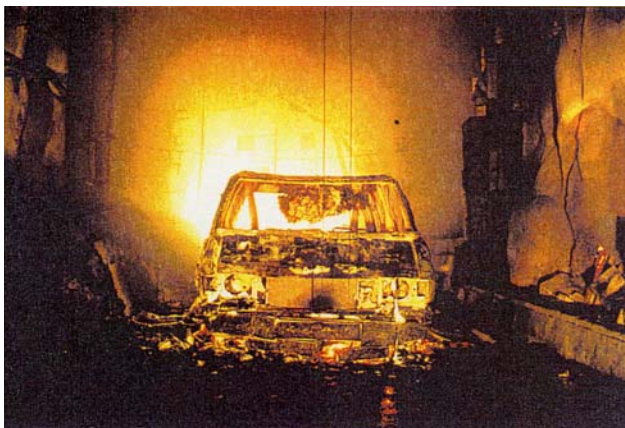
Figure 2.1 Small fire test (photo by 9 EU countries,

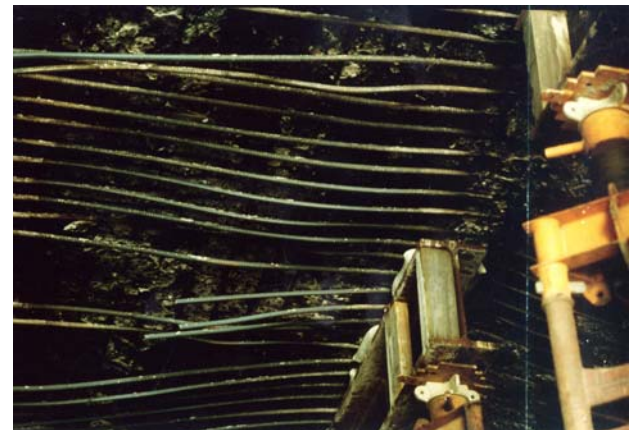
Figure 4.1 Serious damage of concrete slab by fire

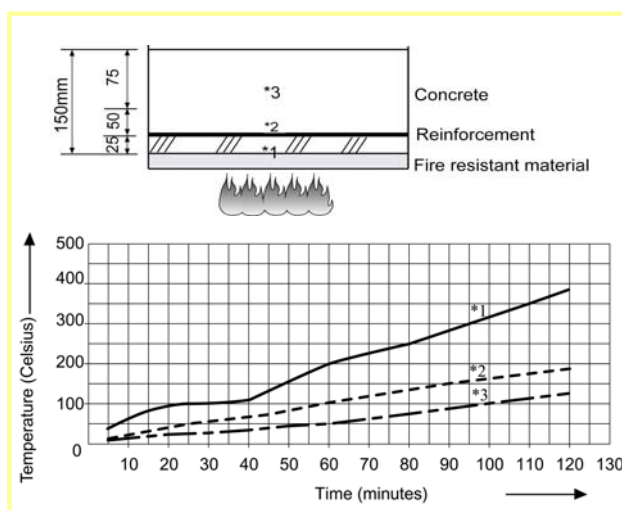
Figure 4.3 Temperature distribution curve by time at Concrete Surface and inside <sup>3)</sup>

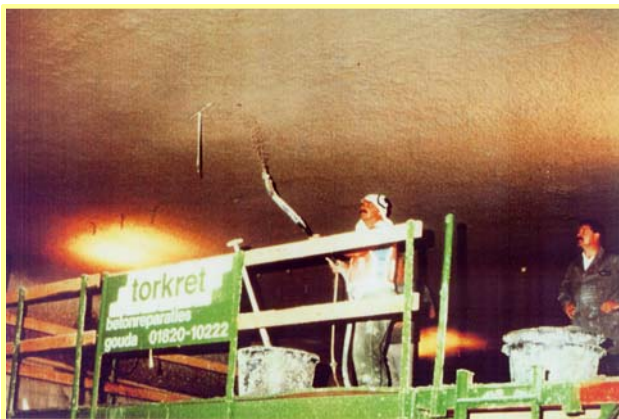
Figure 5.2 Mitigation measures by sprayed fire protection <sup>6)</sup>

Inorganic spray system can be applied easily to complicated shape of structure with narrow locations, and also renovation work is very simple for damaged part of concrete structure. Improved adhesion performances of concrete surface varies due to the surface condition to be necessary. Finished surface is not flat, if in the case of surface cleaning to be necessary, it may be trouble some. If in the case of organic materials are contained, it may produce the toxic fumes and smoke.

The finished sprayed surface is appeared some roughness, so that, finished surface has some of sound absorbent performance. However, which will be stained by smoke and soot. The side wall cladding will be necessary for the better reflection of lighting system and maintenance for cleaning.

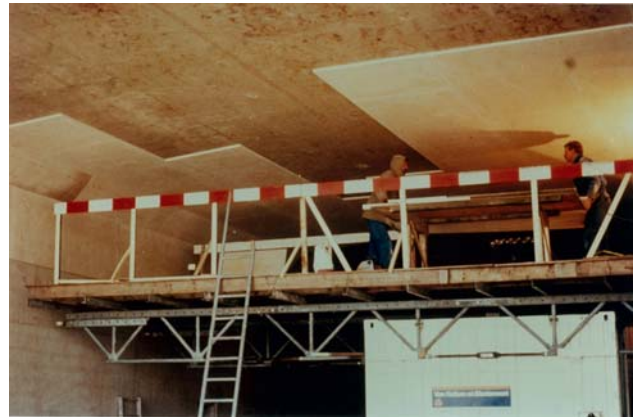
Figure 5.3 Fire protection panel are fixed on the concrete surface (photo by RWS, Netherlands)

Finished surface is smoother than spray system. And also has some sound absorbent performance due to material density. Additionally, level of blemish by smoke and soot is better than spray finished surface.

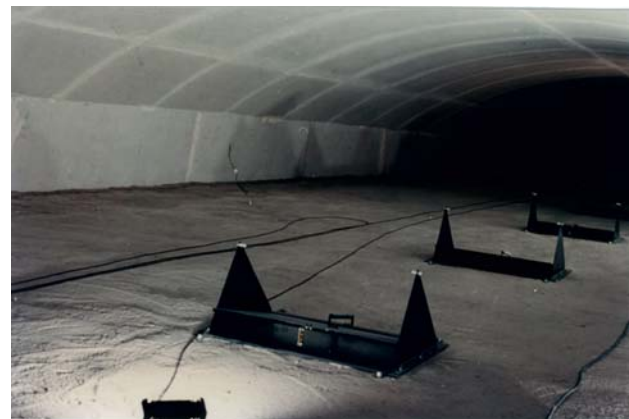
Figure 5.4 Fire protection panel are fixed on the circular ceiling (photo by 4th Elbe Tunnel, Germany)

Figure 5.4 presents the panel installation on the curved surface. This method seems to be more costly than flat surface.

Generally, panel system is applied on the flat surface in rectangular cross section (submerged tunnels in the Netherlands) in many cases. Typical panel dimensions are 1200mm x 300mm, thickness 25-27mm. As fire resistance materials, these are mainly fixed on the ceiling with the vacuum

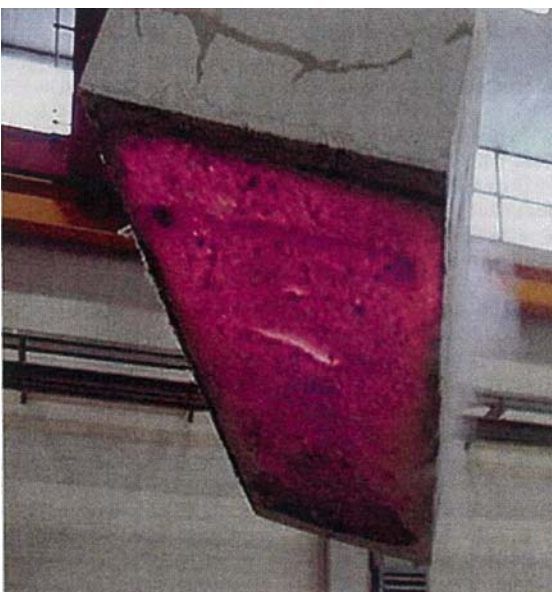
Figure 5.5 High temperature heated chemical fiber concrete specimen <sup>7)</sup>

Figure 5.5 presents the heated in red colored specimen and Figure 5.6 presents the comparison figure of PP(polypropylene) fiber specimen performance and normal concrete specimen. This PP fiber concrete is installed at ceiling part for several tunnels in Austrian road tunnels. If P.P fiber is mixed in concrete (contamination approx 3kg/m<sup>3</sup>), the fire resistance performance was significantly improved up to 1200°C. However, in the case of temperature rise is higher condition by Heavy goods vehicle fire, resistance performance and durability of repetition fire will not be adequate, therefore, further investigation of fire resistance performance of chemical fiber concrete to be necessary.

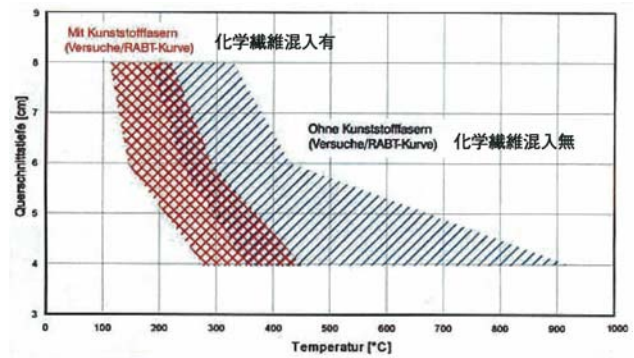
Fig 5.6 Temperature penetration to normal concrete in comparing with chemical fiber mixed concrete <sup>7)</sup>
