Construction of the North-South-Metro Line in Cologne and the accident on March 3rd, 2009

Prof. Dr.-Ing. Alfred Haack
STUVA, Cologne, Germany
Former President of ITA

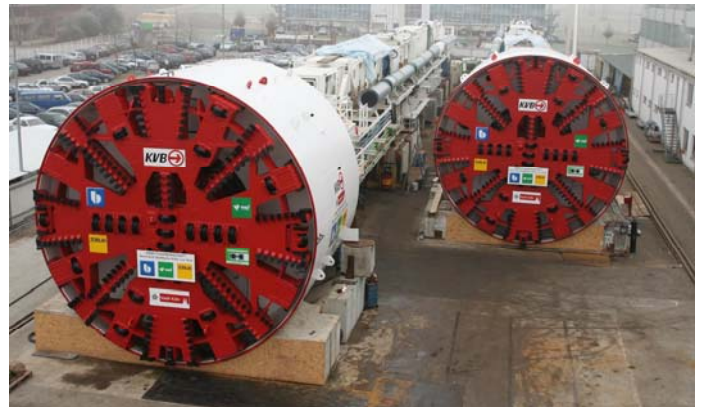
Figure 3. TBMs for southern section.

The two parallel single track running tunnels of the southern section with an internal diameter of 7.3 m were driven by mechanical means continuously from the starting shaft in the south to the target shaft in the north over a length of about 2.7 km using TBMs with an external diameter of 8.4 m (fig. 3). These were finished in summer 2008.

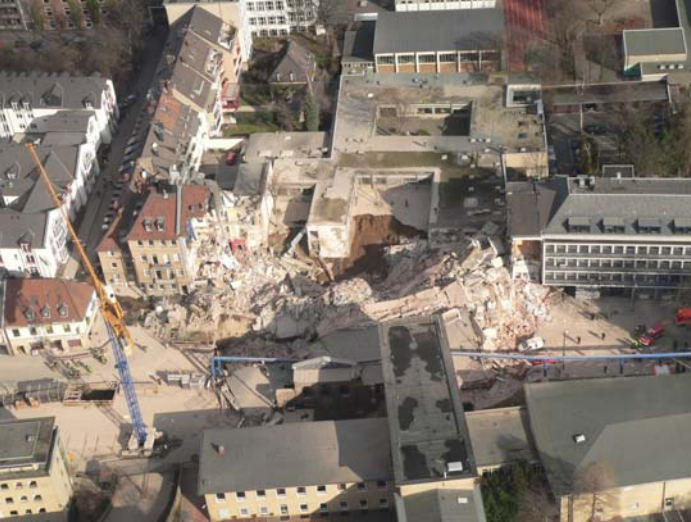
Figure 4. Aerial view of collapsed Historical Archive.

On 3rd of March 2009 during the final excavation work for the 28 m deep open pit of the Waidmarkt turn-off a catastrophic accident happened in the early afternoon. The seven storeys high Historical Archive of the City of Cologne collapsed including one neighbouring building on each side (fig. 4). This Historical Archive hosted 33 km of shelves containing numerous original documents, some older than 1200 years. These documents are covering the history of the City of Cologne but also of the surrounding Rhine area and partly also of entire Germany. Two fatalities were missing for a couple of days covered by masses of debris.
