Reconstruction of Provincial Highway No. 13 Hou-Feng Bridge Damaged by Typhoon Sinlaku

Ping-Hsun Huang*, Hsin-Chih Chen*
Yeong-Jong Liaw*, Tyng-Lo Chang*
CECI Engineering Consultants, Inc., Taiwan*

KEYWORDS: Typhoon Sinlaku, reconstruction, temporary access road, temporary access bridge

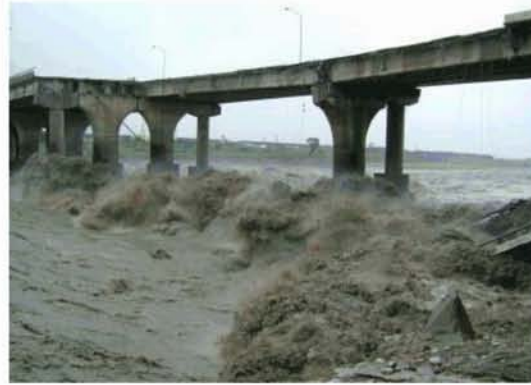
1.2 & 1.3)

On September 12, 2008, during Typhoon Sinlaku invasion, it caused a serious disaster for Taiwan. From 12th 0:00am to 15th 8:00pm, according to the Central Weather Bureau record, there were 1,600 mm rainfall in Taichung County which was ranked as No.1 in Taiwan. The foundation of P2 pier of Houfeng bridge was void for scouring at around 7 pm on September 14, resulted in a bridge deck collapse in north bound lane. And the traffic was disrupted (Photo 1.1). Directorate General of Highways, MOTC immediately built an emergency temporary access road on the downstream side of the bridge site about 100 meters away to reconnect the traffic cross the river. Later on, an emergency temporary access bridge was constructed for the traffic demand. (Figure

Photo 1.2 Houfeng bridge collapsed in Typhoon Sinlaku

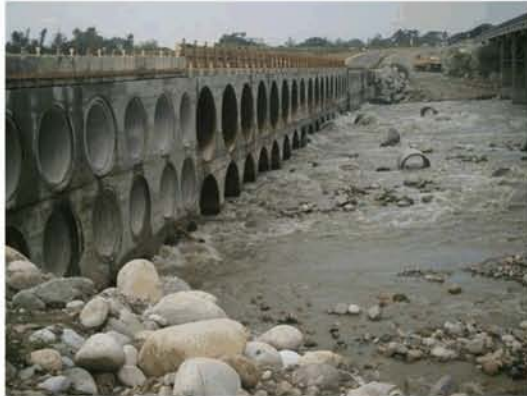
(8) Cast-in-place reinforced concrete box culvert did not match the construction schedule requirements, so the main

components were using steel pipe and the market available RCP pipe. (Photo 2.1)

Photo 2.1 Temporary access road built by steel pipe and RCP pipe

15m long H-section steel piles were used for the temporary access road foundation to have sufficient anti-erosion capability. Steel pipe culvert and RCP pipe were adopted for easy construction and flood passing requirement. Although H-section steel piles and steel pipe culvert could be recycled, the initial cost was still high. For the flood concern, the diameter of existing RCP pipe

in the market was not enough for flood control, but the cost of steel pipe culvert was high. More detailed considerations and planning were needed to casting large diameter RC pipe in a short period of time. Due to the construction schedule and work site geological condition, a hard layer of gravel, relatively high cost H-section steel piles were adopted. However, in other geological considerations, cheaper PC piles could be used to reduce the costs.

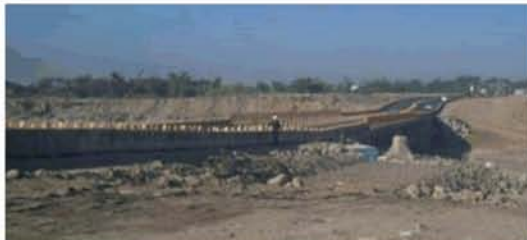
The old Houfeng bridge was interrupted on September 14, 2008, and the temporary access road started to construct on October 5. At the same year, the traffic was reopened on October 26. It took only 21 days to complete a 700 meters long and 15 meters wide, two-way four-lane temporary access road. (Photo 2.2)

Photo 2.2 Completed temporary access road

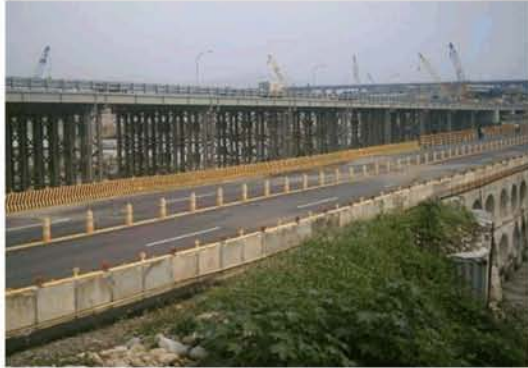
Temporary access bridge made in steel was started to constructed on October 15, 1997 and was completed by December 20 of the same year. It took only 66 days to

construct the 300 meters long and 15.5 meters wide, two-way four-lane steel bridge for 15 tons of heavy vehicle traffic. (Photo 3.1)

Photo 3.1 Completed temporary access bridge

- (1) Temporary access bridge was 61 meters away from the main bridge, 38 meters away from the temporary access road. Temporary access road was functioned as riverbed protection work to protect the temporary access bridge.
- (2) 300 m temporary access bridge across the main river, the elevation of bridge deck was suitable for up to 100-year flood return period to fulfill the flood control needs.
- (3) Considering the duration factor, is still adopted to quickly enter the gravel riverbed H-shaped steel as the basis for flood.
- (4) Simple construction, fast multi-span simply supported steel I girder bridge, and waved steel sheet with RC bridge deck system were used.

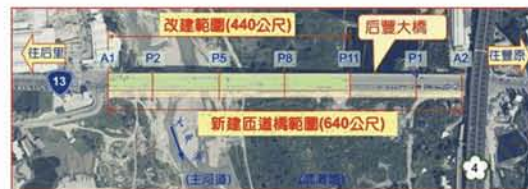
- (1) The original plan was only 280m long reconstruction, P1~P6 pier, in the main river channel. However through a detailed hydraulic analysis, the original plan was not able to meet the needs of the flood control section. It was finally approved the alteration of 440m long reconstruction, P1~P10 pier, and additional ramp, P11~A2, in PCI girder. (Figure 4.1, 4.2)

Figure 4.1 Plan view of Hou-Feng Bridge

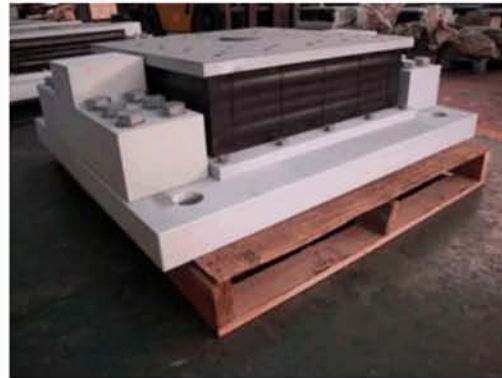
(4) In the seismic design, Houfeng bridge not only met the seismic design specification, but also used high damping rubber bearing (HDRB). (Photo 4.1) By using the HDRB the seismic force can be distributed to all the piers to reduce the impact of seismic forces on a bridge. Elasticmeric bearing support has three advantages: (a) the seismic force acting on each pier was reduced, so that bridges can be multi-span continuous; (b) under earthquake, the elasticmeric bearing can appropriately extend vibration period to reduce the seismic force; (c) by adjusting the horizontal stiffness of elasticmeric bearing, the level of force for each pier could be also adjusted. Moreover, the usage of high damping rubber bearing has three more advantages: (a) the normal horizontal force from elongation or shortening can be reduced; (b) less vibration caused by normal applied load (live load, wind load, etc.); (c) considerable energy absorption (damping) function can reduce the seismic force, effectively reduce the number of piles, the

size of the pile cap, project costs, construction time and the scouring.

Photo 4.1 High damping rubber bearing

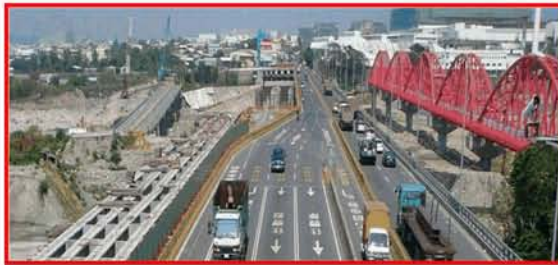
The main bridge construction was started on October 20, 2008. By all the effort, the first stage traffic was opened on

June 29, 2009. Only eight months of construction, 440 meters long, 15.5 meters wide, two-way four-lane steel box girder bridge was built and opened to service for all kind of vehicles.(Photo 4.2) The second stage was completed on July 23, 2001 for the remaining 440 meters long, 15.5 meters wide, four-lane steel bridge and 640 meters long, 10 meters wide, two-lane ramp. (Photo 4.3)

Photo 4.2 Serviced Houfeng ridge at first stage

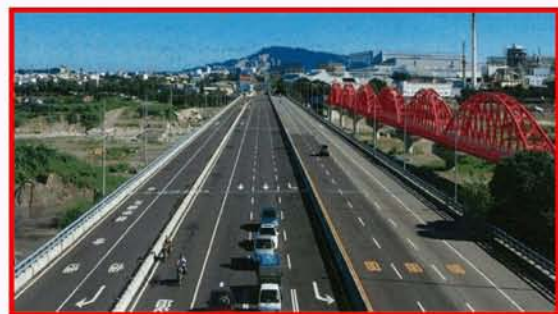
Photo 4.3 Completed Houfeng bridge

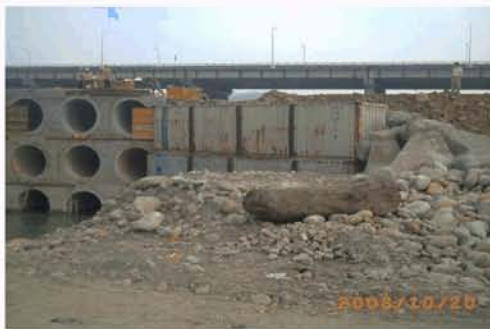
- The detour road at both ends of the embankment was not built in pile foundation. Containers were adopted for the reinforcement, and they were not able to prevent the flush-away by the flood. (Photo 5.1) However, there was no better method to avoid the problem for this section of detour road.

Photo 5.1 Container embankment

(7) Steel container filled with riverbed material combined with steel wire strengthening was used for over high embankment to overcome the earth filling construction problem for the existing bridge connection. Moreover, it could effectively shorten the construction time.
