SIGNIFICANCE OF VISUAL TEST AND HAMMERING TEST TO MANAGE CONCRETE STRUCTURE DURABILITY

ABSTRACT: Inspection of reinforced concrete is important to ensure durability, and visual test and hammering test are widely applied to the inspection. In this study, reliability on the result of the visual test for cold joint and sand streak and the hammering test for checking concrete strength distribution was investigated, and it was clarified that error among those test results obtained by more than 100 students is fairly small. Then method to estimate durability of reinforced concrete based on visual test results is proposed and general concepts for applying the hammering test to evaluation of concrete strength distribution is described.

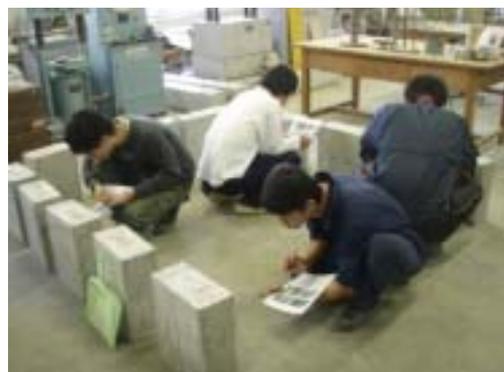
Fig.2 Photograph of student survey on Cold joint

Student survey was carried out as shown in Fig.2, after distribution of the questionnaire as shown in Fig.3 to each student. The photograph on the

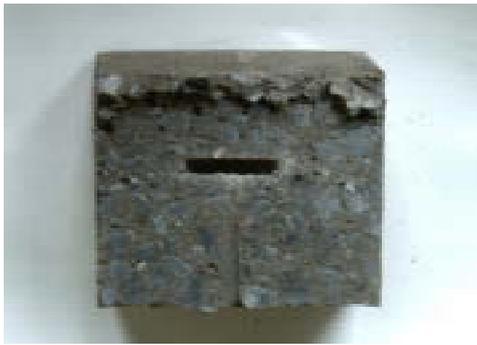
Fig.6 Defect on photograph of cut section

Specimens for 100 students to inspect defect in hardened concrete were rectangular specimens (L300×W150×D150) as shown in Fig.5 and Fig.6. The concrete consisted of river sand and crushed stone. The void defect was performed by dissolving styrene foam in acetone, i.e. after concrete hardened, preplaced styrene foam at defect position was dissolved in acetone injected through straw set behind of specimens, and the solution was taken out.

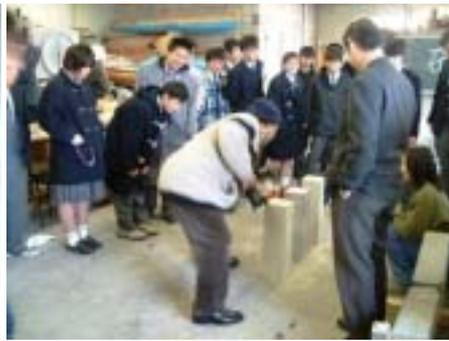
Fig.7 Photograph of student inspecting compressive strength

After explanation that “The higher the compressive strength, the better the rebound, the higher the tone,” and “On defect, tone differs from other parts,” student survey on strength comparison and on defect inspection was carried out as shown in Fig.7 or Fig.8 respectively.

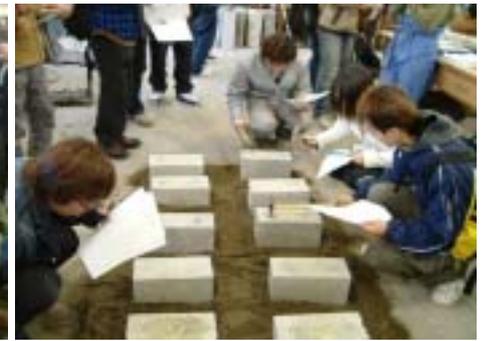
Fig.8 Photograph of student inspecting internal defect
