Damage evaluation<u>Change of hydrogen concentration</u> after ion beam irradiation on polyimide films with 100-400 degree C annealing

Michio Watamori

Department of Electronic and Photonic Systems Engineering, Kochi University of Technology,

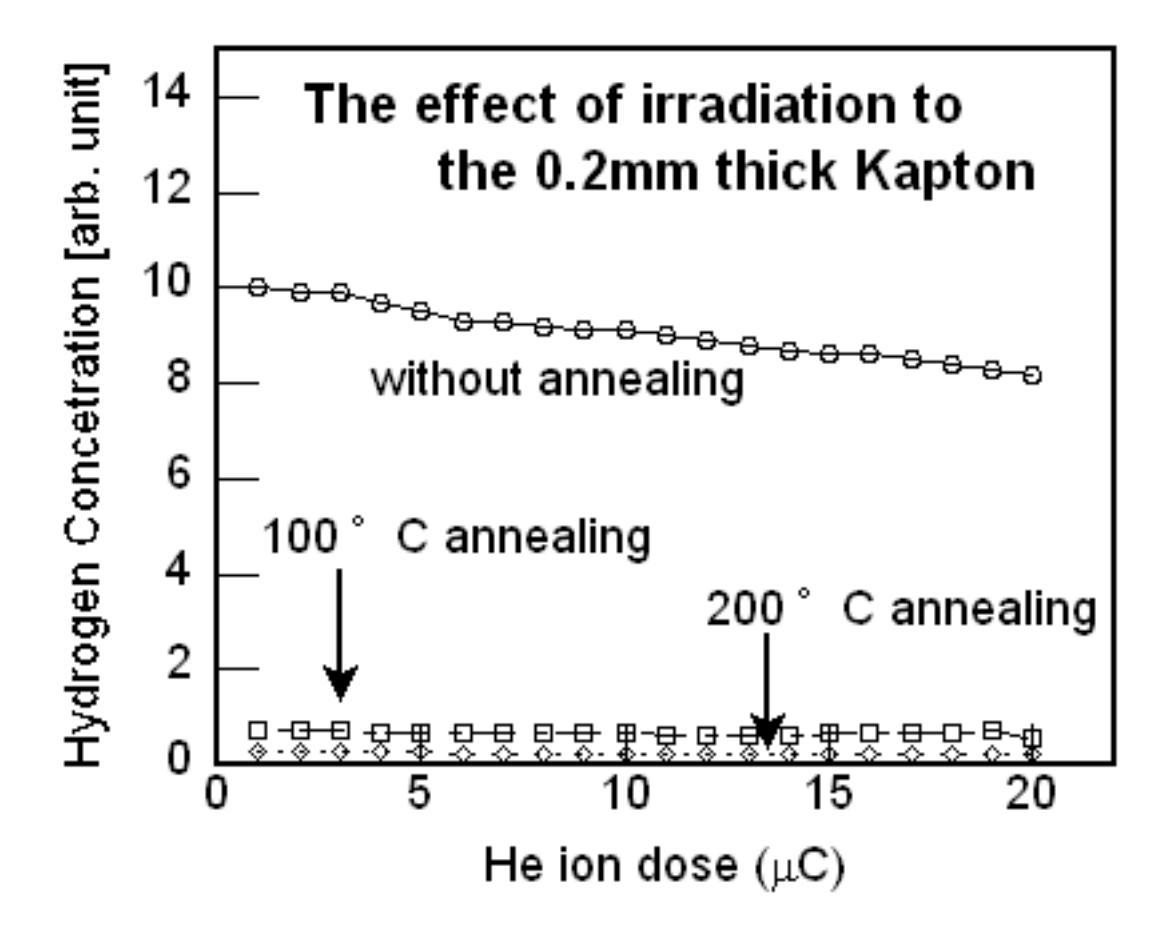
Fig. 1 M.Watamori

- Fig. 1 Variation of hydrogen concentration for successive dose of He ion beam for the 0.2mm thick Kapton films. The ordinate represents absolute hydrogen compositional ratio. The annealing conditions are (a) no annealing, (b) 5 minute annealing at 100°C and (c) 5 minute annealing at 200°C.

Figure 1 shows the variation of hydrogen compositional content (concentration) for successive dose of high energy He ions as a function of sample annealing temperature. Film thickness of the Kapton used for this experiment was 0.2mm. Ion dose is plotted in unit of μ C, where 1 μ C is equivalent to 3.45×10¹³ ions/cm² irradiation. The ordinate shows the absolute relative hydrogen concentration in unit of compositional ratio normalized by earbon initial hydrogen compositional ratio (C:22H:10) where earbon concentration is assumed not to decrease under the high energy ion irradiation. Stoichiometric composition of Kapton-H is

$C_{22}H_{10}N_2O_5$, which is also used for the correction of hydrogen recoil cross section for the first time ERDA-RBS simultaneous measurement taken by 1µC He dose at room temperature[6]. As shown in Fig.1, gradual decrease of hydrogen content from the stoichiometry was observed as the increase of ion dose at room temperature. This result is similar to those already reported papers[2,3,5-7]. However, tremendous depletion of hydrogen concentration was observed after 5 minute annealing as high as 100°C, even though no ion beam irradiation was done(Exactly saying, 1µC ion dose was done to measure the hydrogen concentration, but this ion dose is quite small). The

absolute concentration of hydrogen decreased up to 0.75 from 10.0, though any visible change could not be observed in the film. Film shape remains same, without roughening, shrinking and coloring, after annealing even at 300°C in vacuum. From the result of RBS, no decrease of other elements of oxygen, nitrogen and carbon was observed, indicating predominant desorption of hydrogen element alone (without the form of H₂O). Easy idea of H₂O desorption due to annealing is also denied in the point of recovery of hydrogen concentration over 300°C annealing in the 0.5mm nand 0.7mm thick Kapton films. In the case of 200°C annealing for 5 minute, hydrogen concentration decreased more up to 0.33%. For the ion beam irradiation up to 20µCThen, hydrogen concentration changed nearly equal or a little bit decrease monotonously for 100°C annealed and 200°C annealed films for ion beam irradiation shown in Fig.1. For the Kapton films, the effect of heating up is predominant for hydrogen desorption compared with ion beam irradiation. It is noted that after 300°C annealing, no hydrogen could be detected within our ERDA detection sensitivity for the 0.2mm thick Kapton film. Figure 2 shows the raw ERDA hydrogen spectra taken at the 1μ C ion dose for the 0.2mm thick Kapton films without annealing, with 100°C annealing and with 200°C annealing. For the case of annealing, quite small hydrogen signals were observed compared with the spectrum for no annealing. From Fig.2, it has been found out that the hydrogen depletion extended to whole observable thickness(about $0.3\mu m$). It is not yet clear why such a tremendous depletion of hydrogen content takes place.

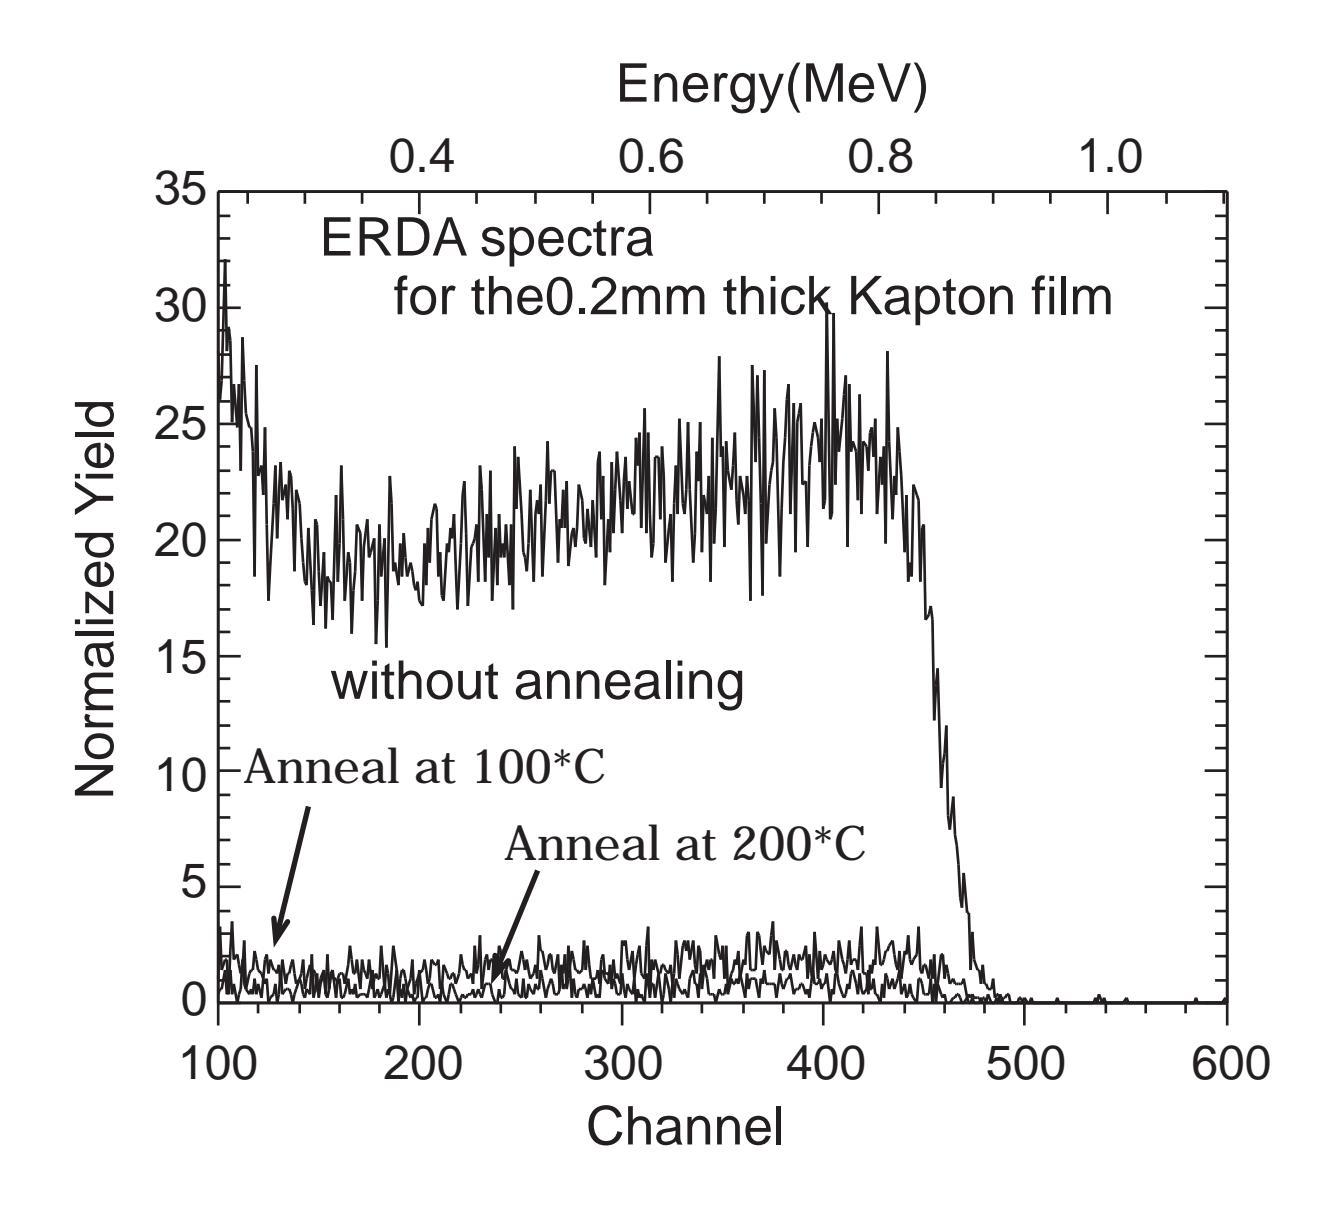
Fig. 2 M.Watamori

- Fig. 2 ERDA hydrogen spectra taken at the 1µC ion dose for the 0.2mm thick Kapton films without annealing, with 100°C annealing and with 200°C annealing. Depth distribution of hydrogen concentration is found to be nearly constant within the observable thickness(about 0.3µm).

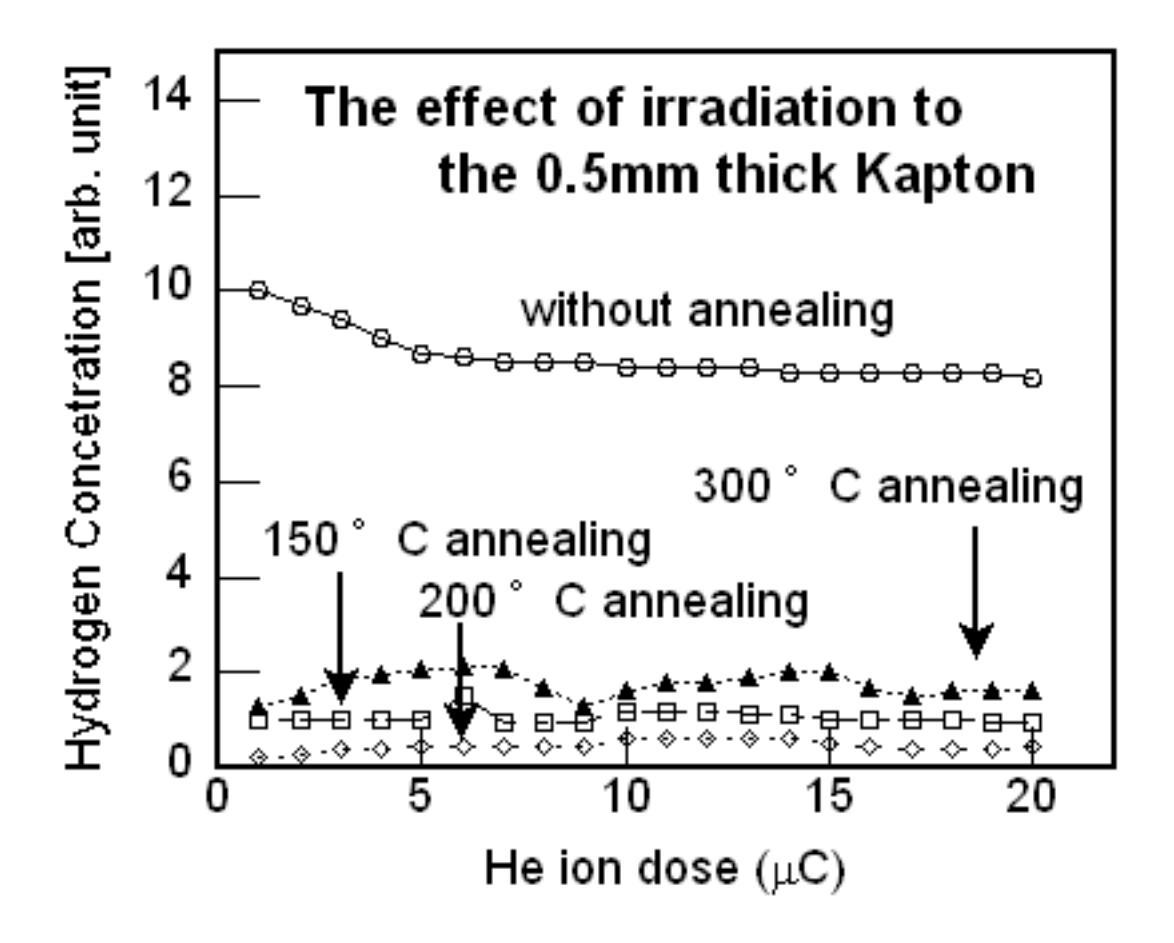
Fig. 3 M.Watamori

- Fig. 3 Variation of hydrogen concentration for successive dose of He ion beam for the 0.5mm thick Kapton. The annealing conditions are (a) no annealing, (b) 5 minute annealing at 150°C, (c) 5 minute annealing at 200°C and (d) 5 minute annealing at 300°C.

Figure 3 shows the variation of hydrogen concentration for successive dose of He ions as a function of annealing temperature. Film thickness of the Kapton was 0.5mm. In the case of irradiation to the 0.5mm thick Kapton film at room temperature, gradual decrease of hydrogen concentration against the ion dose has been observed. This agrees well with the case of ion beam irradiation to the 0.2mm thick Kapton film. After 150°C annealing for 5 minute, hydrogen content decreased up to 1.010%, which shows same tendency with the 0.2mm thick Kapton film case. After 200°C annealing for 5 minute, hydrogen concentration slightly, and no fluctuation of hydrogen concentration against the ion beam irradiation was observed. However, after 300°C annealing for 5 minute, hydrogen content tent recovered a little for the 200°C annealed film. Moreover, fluctuation of hydrogen concentration against the ion beam irradiation was clearly observed shown in Fig. 3. For the case of 0.2mm thick Kapton film, as hydrogen atoms could not be detected after 5 minute annealing at 300°C, the result of 300°C annealing for 0.5mm thick Kapton film is in clear contrast with the result for 0.2mm thick Kapton film.

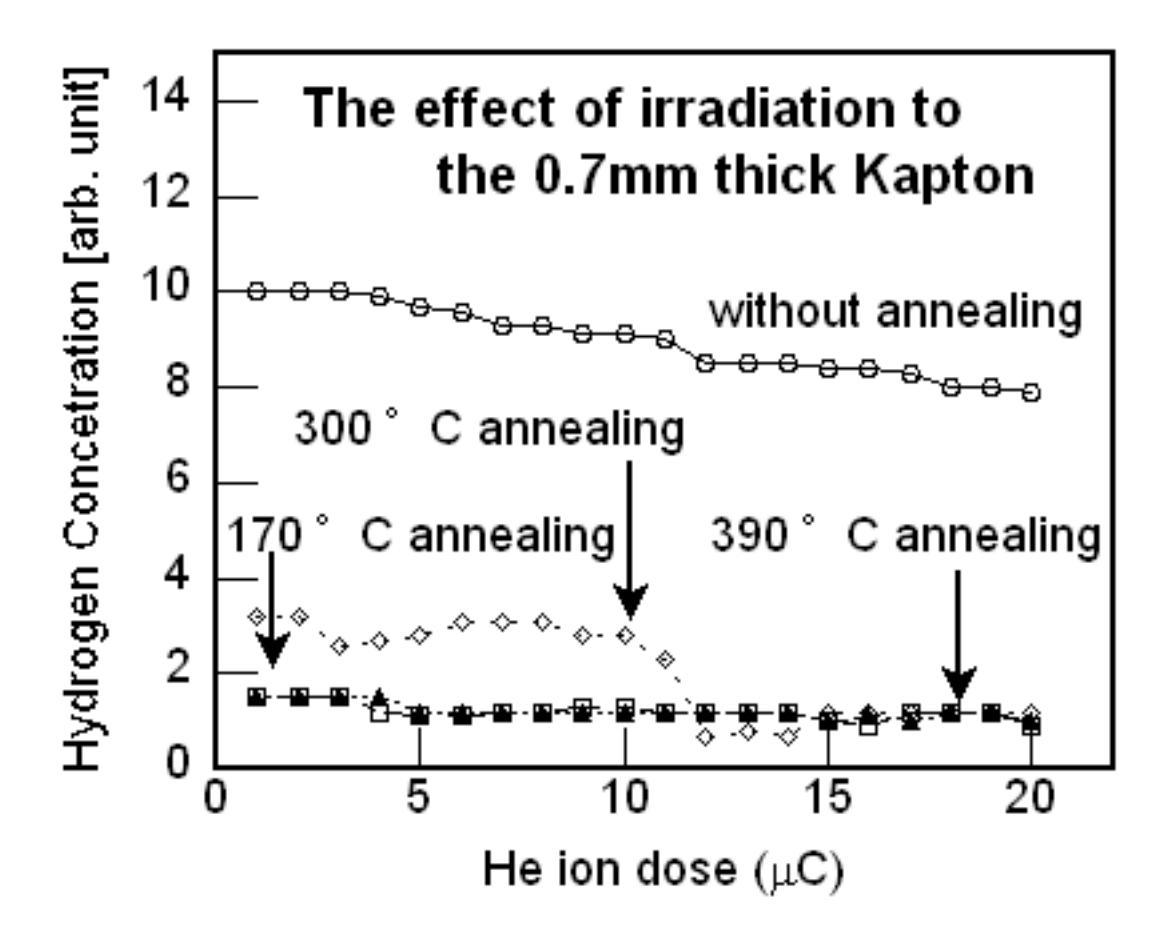
Fig. 4 M.Watamori

- Fig. 4 Variation of hydrogen concentration for successive dose of He ion beam for the 0.7mm thick Kapton. The annealing conditions are (a) no annealing, (b) 5 minute annealing at 170°C, (c) 5 minute annealing at 300°C and (d) 5 minute annealing at 390°C.

Figure 4 shows the variation of hydrogen concentration for successive dose of He ions as a function of annealing temperature. Film thickness of the Kapton was 0.7mm. In the case of irradiation to the 0.7mm thick Kapton film at room temperature, gradual decrease of hydrogen concentration against the ion dose has also been observed, showing same tendency with the 0.2mm thick Kapton film and the 0.5mm thick Kapton film. After 170°C annealing for 5 minute, hydrogen content decreased up to $\frac{1.515\%}{1.515\%}$, which also shows same tendency with the 0.2mm thick Kapton case and 0.5mm thick Kapton case. After 300°C annealing for 5 minute, hydrogen content recovered for the 170°C annealed film. The tendency is nearly same as the

case of irradiation to the 0.5mm thick Kapton film. However, the extent of hydrogen concentration after 300°C annealing to the 0.7mm thick Kapton film is 3.232%, twice greater than the case for 300°C annealing to the 0.5mm thick Kapton film, indicating much more recovery at the same temperature. Then, after 390°C annealing for 5 minute, hydrogen content decreased again up to 1.5. In this film, fluctuation of hydrogen concentration against the ion dose was observed severely for the annealed films at 300°C and at 390°C. For detailed discussions, I summarize the characteristics of the variation of hydrogen concentration for successive change of ion beam dose under the high temperature annealing for 0.2mm, 0.5mm and 0.7mm thick Kapton films. Common characteristics and difference for each sample is as follows.

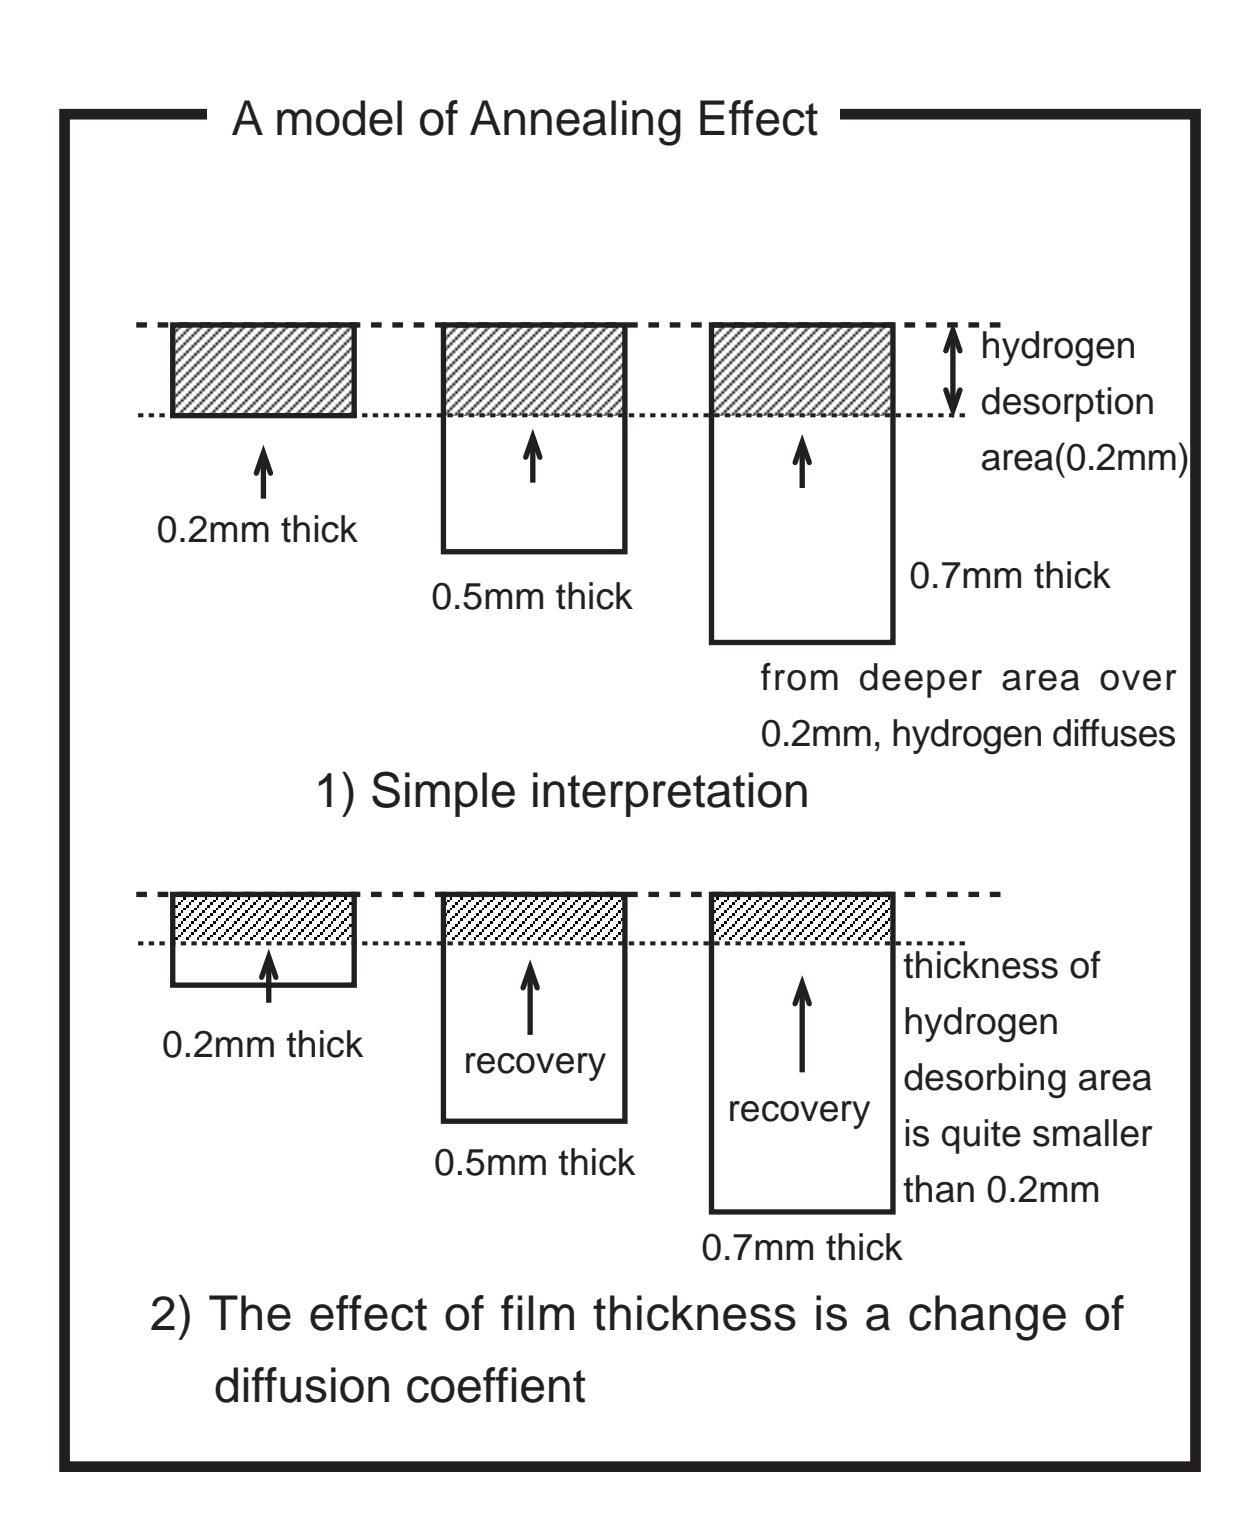
Fig. 5 M.Watamori

- Fig. 5 A model of the annealing effect and irradiation effect on the Kapton films with different film thicknesses of 0.2mm, 0.5mm and 0.7mm thick.

I show the model of the annealing effect and irradiation effect on the Kapton films with different film thicknesses in Figure. 5. This is only my hypotheses. One hypothesis is shown upper side in Fig. 5. I call it for "Simple interpretation". As the difference is only film thickness for each experiment, over 300°C annealing hydrogen atoms go toward surface area from at least 0.2mm deeper area by diffusion for thick films. In this model, the problem is the possibility of desorption of hydrogen locating in the 0.2mm deeper area for only 100°C annealing. The dis-

tance of 0.2mm seems to be huge. Second one is shown lower side in Fig. 5. In this model, desorption area of hydrogen is quite shallower than 0.2mm depth. The difference is hydrogen diffusion coefficient. At high temperature, hydrogen diffusion coefficient changes to be larger for thick films than it of thin films. Though it is not so realistic, if the hypothesis is correct, the reason where hydrogen appears in the surface region after 300°C annealing for thick Kapton films can be explainable. I did not take into account the change of density with hydrogen loss or possible thermal gradients due to the poor thermal conductivity. As the experimental results are few, I cannot say any comment. I also don't know whether hydrogen loss is homogeneous or not laterally in this system. Anyway, further experiment and discussion must be needed in this system. It is noted that we show the hydrogen concentration as an average value from topmost surface to 0.3µm depth. For the case of 0.2mm thick Kapton film (at all annealing temperature), and 0.5mm thick Kapton film and 0.7mm thick Kapton film for less than 200°C annealing, depth profile was uniform. However, depth profile of hydrogen for thick Kapton films after high temperature annealing is not rather than flat. Just inside the film close to the surface (about 0.1µm deeper from the surface), hydrogen concentration is less than its of surface area's. This might be also the key to solve the phenomena.
