# QUANTIFICATION OF CHANGES IN SURFACE CONDITIONS OF AIRPORT PAVEMENTS IN JAPAN

Yoshitaka HACHIYA, Takashi WATANABE and Kentaro KITAOCHI  
Service Center of Port Engineering (SCOPE), JAPAN

**KEYWORDS:** airport pavement, surface condition, rehabilitation need

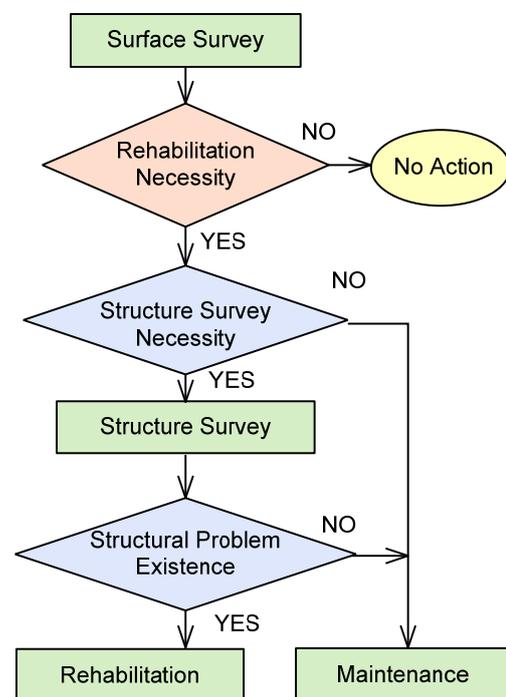
**Figure 1** shows a flow chart of the evaluation and rehabilitation subsystems, in which fundamental evaluation, and maintenance and rehabilitation process consists of the following steps.

**Figure 1** Flow chart of evaluation and rehabilitation subsystems for airport pavement management

### 1) Surface condition evaluation

The condition of the airport pavement surface is surveyed every three years. When the physical condition of the surface is judged to have seriously deteriorated, certain rehabilitation work may become necessary. In order to determine a suitable time for carrying out this rehabilitation work, an objective method using the already-mentioned PRI has to be applied.

### 2) Structural condition evaluation

If the above-mentioned PRI method indicates that certain rehabilitation work is necessary, the structural condition of the pavement has to be checked. Non-destructive testing procedures using a Falling Weight Deflectometer (FWD) are adopted for airport pavements.

### 3) Rehabilitation method selection

If the structural condition of a pavement is found to be unsound, rehabilitation work is necessary. However, some maintenance work may be needed even if the pavement is sound structurally.

### 4) Rehabilitation work design

Based on the decision made above, the procedure for the rehabilitation work should be determined. In general, there are two methods of rehabilitation, overlay and reconstruction.

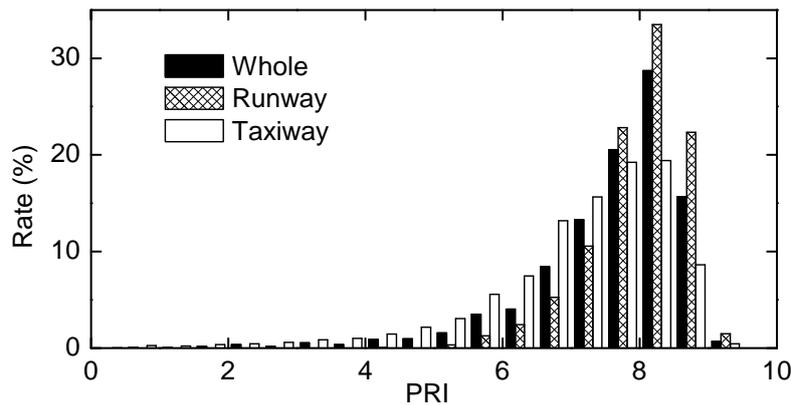
**Figure 2** shows the survey results for the state of the asphalt pavement at 23 of these airports, conducted between 1998 and 2002. The PRI values for runways and taxiways are different, with runways averaging 8.0 and taxiways 7.1. There is a difference of about ten percent on average between runways and taxiways, with taxiways exhibiting the smaller

values of PRI. All types of distress, including cracking, rutting, and roughness, are more severe on taxiways than on runways and this is reflected in the PRI.

**Figure 2** PRI Distribution

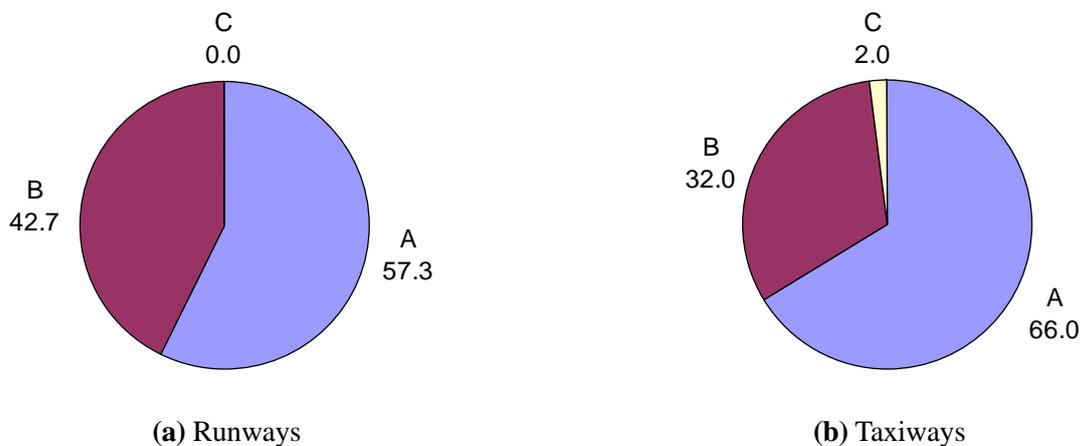
**Figure 3** shows the need for rehabilitation work as judged from these PRI values in accordance with the criteria given in **Table 1**. Looking at runways, the proportion of pavements classified as A is about 60% and the remainder is B. On the other hand, about 70% of taxiway pavements are ranked as A, but there are some ranked as C. Although PRI values are smaller for taxiways than for runways, the difference in need for rehabilitation results from the different criteria used for runways and taxiways.

**Figure 3** Need for Rehabilitation Work

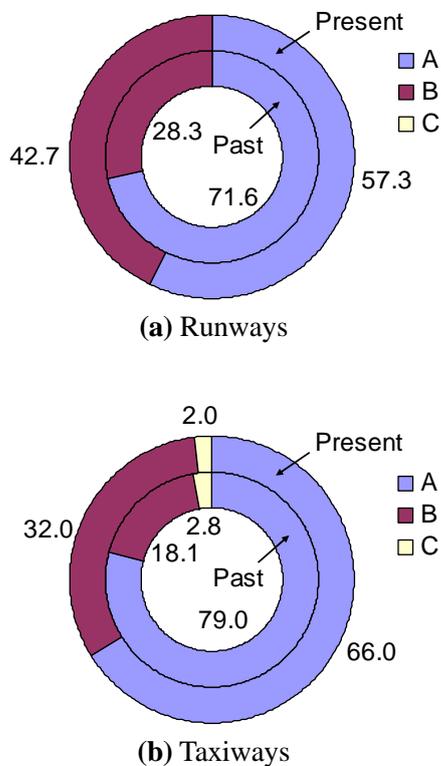
**Figure 4** summarizes the need for rehabilitation work based on PRI. The proportion judged as A is ten points or more lower now than in the past survey, both for runways and taxiways, while there are more B ranks today. However, there is little difference in the proportion judged as C between the current and past surveys.

Clearly, the condition of airport pavement surfaces has worsened in the 20 years since the earlier survey, with the proportion ranked as B increasing over the years. This might suggest that the pavement management system, including the methodology

**Figure 4** Comparison of Judged Need for Rehabilitation Present and Past

used to evaluate pavements (the method and the survey interval) is barely adequate to maintain the surface in good condition.

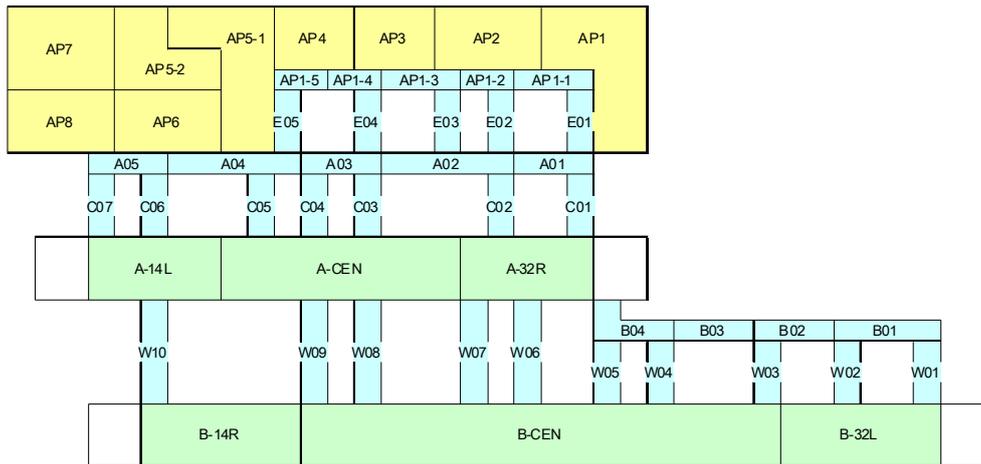
The surface conditions of runways, taxiways and aprons were evaluated in 163, 273, 101 units, respectively. When the annual changes in PRI and the recovery of PRI due to rehabilitation works are analyzed in each unit, the results vary largely. Thus, the units are summed into several groups as shown in **Figure 5**. The runways A and B were separated into three blocks (two end parts and one intermediate part) in each, and the aprons were divided into nine blocks in consideration of the aircraft running lines. The taxiways were divided into perpendicular taxiways, high-speed exit taxiways and parallel taxiways.

**Figure 5** Groups for PRI calculation at Osaka Itami Airport

When calculating the annual change in PRI, only the data measured in three or more times between the continuous rehabilitation works are used. For asphalt pavements, the average annual changes in PRI for runways, taxiways are 0.1 - 0.2, 0.1 - 1.2, respectively. The recovered amount of PRI by applying the rehabilitation works scarcely varies in rehabilitation works conducted at Osaka Itami Airport.
