# SEISMIC HAZARD IN TAKAMATSU JAPAN

**ABSTRACT:** The harbor city Takamatsu has population 420,000 and situated on the northern shore of Shikoku Island, southwest Japan. Downtown of Takamatsu is located mainly on delta and fill-up lands and was extensively damaged by storm surge due to No.0416 typhoon in 2004. Earthquakes in the Nankai Trough, typically of magnitude more than M 8, have been extensive damaging to the city every hundreds years and the next one is expected to occur before middle of 21st century. Deltic deposit of downtown of Takamatsu is composed of the Holocene sandy sediments. The reclaimed lands are composed of unconsolidated sandy and silty sediments, dredged soils and waste materials. Therefore, liquefaction and successive tsunami of 2m+ are the serious threat to the city. This paper estimates the seismic hazards in Takamatsu from the study of past disasters and liquefaction risk by the help of geo-informatics.

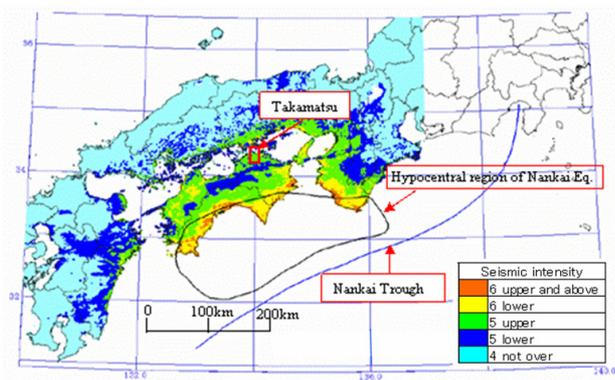
**Figure 1.** Estimation of seismic intensity for future Nankai Earthquake (modified from Central Disaster Prevention Council, 2003)

Takamatsu is situated on the northern shore of Shikoku Island, southwest Japan. Shikoku Island is situated on the Eurasian Plate. About 120-180km from south coast of Shikoku, the Philippine Plate is subducting beneath the Eurasian Plate along the Nankai Trough. Earthquakes in the Nankai Trough, typically of magnitude M 8+, have been considered the primary source of seismic hazard for the island and Takamatsu. Takamatsu has suffered serious damage by the Nankai Earthquake in past. The Headquarters for Earthquake Research Promotion (2005) estimated that the probability of the next Nankai Earthquake is 50% within 30 years from 2005, and it is 80% within 50 years. Estimation of seismic intensity of future Nankai Earthquake is shown in Figure 1.

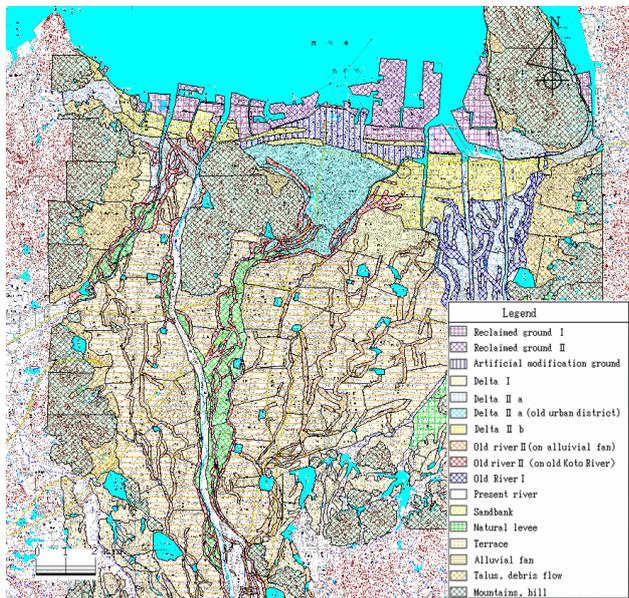
**Figure 2.** Micro-topography of Takamatsu Plain

Downtown of Takamatsu is located mainly on delta and reclaimed lands, and urban areas are developing on the fan of Koto River and the flood plain of other rivers (Figure 2). As the ground level of delta and reclaimed lands is usually below 3m, tsunami caused by Nankai Earthquake and flood storm surge by typhoon are great threat to Takamatsu city. In addition, earthquake shaking can be easily simplified in delta and reclaimed lands, thus the city has great risk of liquefaction. Therefore combined research on earthquake tremor, liquefaction and tsunami is necessary to estimate the seismic hazards associated with future Nankai Earthquake.

The Takamatsu plain is mainly composed of the alluvial fan of the Koto River, the subordinate flood plains of the Shin, Kasuga and Honzu Rivers, deltas of these rivers, and landfills along shore (Figures 2). Downtown Takamatsu is mainly located on deltaic deposits and the urban area is developing on the fan of Koto River, flood plains of other rivers and reclaimed lands.

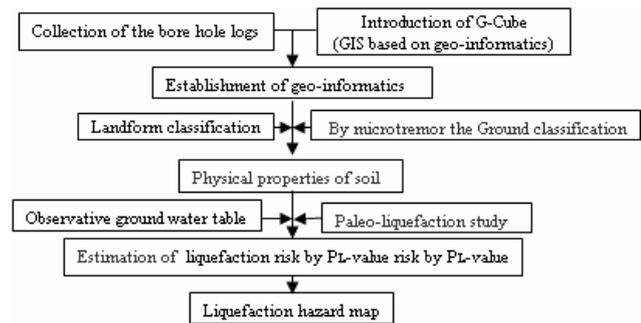
**Figure 3.** Flow chart of the research

The objective of this study is to estimate the seismic hazards in Takamatsu from study of past disasters and liquefaction risk by the help of geo-informatics. First we have developed geo-informatics by using G-Cube (Integration Ground Information Management System by Chuo Kaihatsu Co., Ltd.) and about 1,500 borehole logs are registered into the geo-informatics. The ground conditions are classified into three categories by the help of micro-topography and microtremor

observation. The liquefaction risk is also estimated on the basis of  $P_L$ -value (Figure 3).

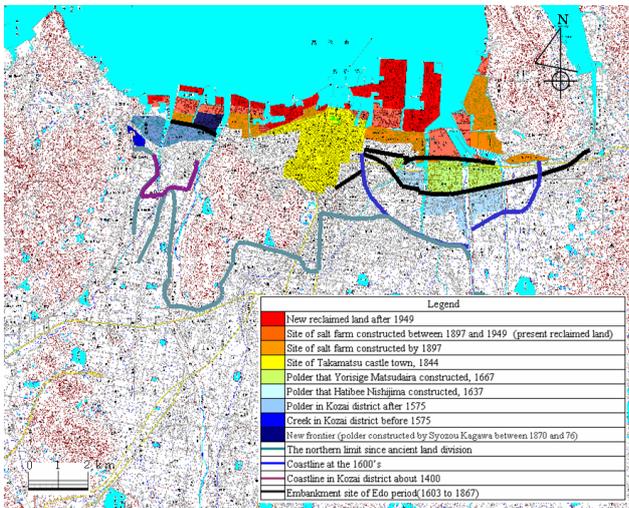
Figure 4. History of land use on Takamatsu Plain

Reclaimed lands have been developed for paddy fields and salt pans since the 17th century and salt pans were filled up in 1970s (Figure 4). These area are composed of soft sandy deposits, dredged soils and waste materials.

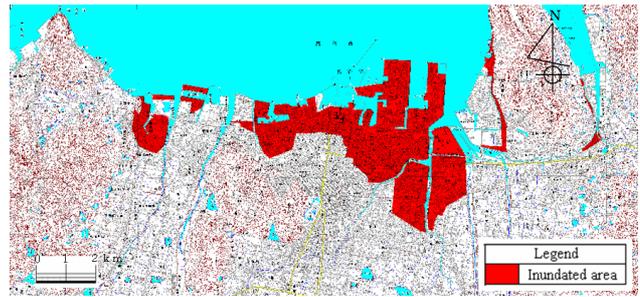
Figure 5. Inundated area by storm surge due to Typhoon No.0416 in Takamatsu (modified from Takamatsu city, 2004)

Typhoon No.0416 caused storm surge disaster on Aug. 30<sup>th</sup> to 31<sup>th</sup>. Storm surge at Takamatsu harbour recorded 2.46m above sea level, which have exceeded past record to 0.64m. As the height of most revetment around Takamatsu port have been designed to be only 2.05m, sea water flew into the downtown area and about 15,600 houses were inundated. The inundated area by Typhoon No.0416 (Figure 5) is almost same inundated area by Nankai Earthquake tsunami estimated from Kagawa Prefecture (Figure 6). This indicates that the Nankai Earthquake tsunami will cause severe damage in downtown Takamatsu.

The tsunami flood hazard map (Figure 6) and high tide flood area (Figure 5) clearly shows that the reclaimed lands for paddy fields are lower than new landfill area near the shore. This topography will cause deeper and longer inundation in the past reclaimed paddy field area and will cause destructive damage by next Nankai Earthquake tsunami.

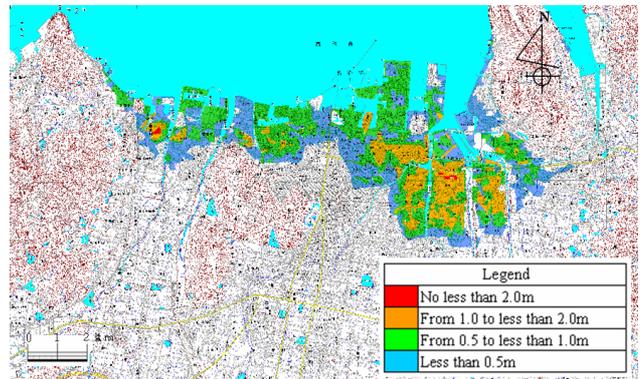
Figure 6. Flood area by Nankai Earthquake tsunami estimated from Kagawa Prefecture (2004)

Downtown Takamatsu is composed of Holocene sandy deltaic sediments. Reclaimed lands are composed of soft sandy and silty deposits, dredged soils and waste materials which have very high risk of liquefaction (Figure 13) and amplification of tremors (Figures 10 and 11). Unfortunately almost all seawall and bank have designed neither as earthquake proof nor to deduce liquefaction. Therefore, liquefaction and successive tsunami (2m+) (Figure 6) are a serious threat to the city near shore.

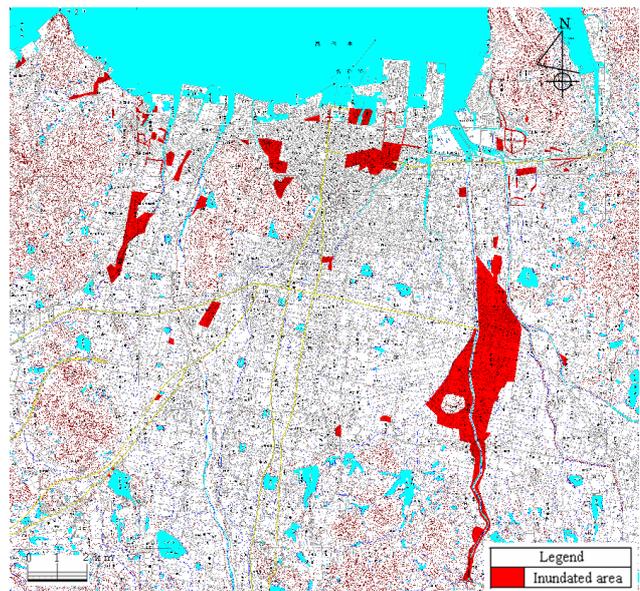
Figure 7. Inundated area by Typhoon No.0423 in Takamatsu (modified from Takamatsu city, 2004)

Typhoon No.0423 caused flood along the Kasuga and Honzu rivers on Oct. 20<sup>th</sup> and about 5,600 houses were inundated (Figure 7).

The liquefaction hazard map (Figure 13) and inundation map by typhoon No.0423 (Figure 7) also suggest that inundated areas and their vicinities are highly liquefiable and have possibility of inundation

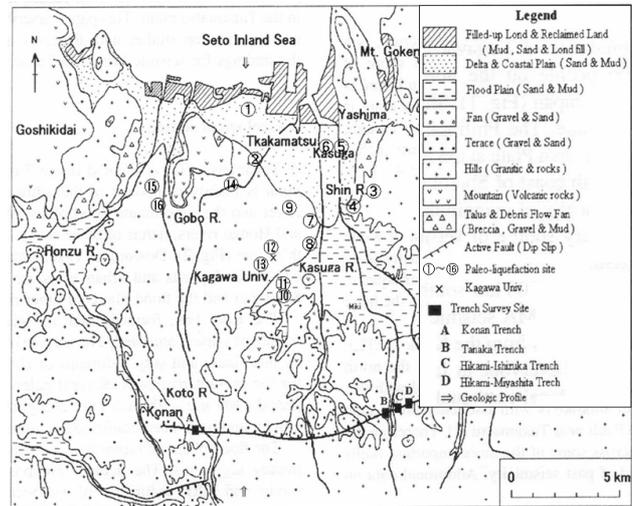
**Figure 8.** Outline of topography of Takamatsu area including liquefaction sites

The 16 paleo-liquefaction sites in Takamatsu plain have been reported by archaeologist (Kinoshita, 2000, and Oshima, 1996). According to these reports, the 9 sites of the paleo-liquefaction are located on the Koto Fan and 7 sites are located on the delta (Figure 8). It is interesting to note that the paleo-liquefaction sites are concentrated on the eastern part of the Koto Fan. Detailed survey of micro-topography and archaeology have demonstrated that most of the paleo-liquefaction

sites are located along the paleo-channels in reclaimed land or marshes on the fan(Hasegawa& Finn,2002).

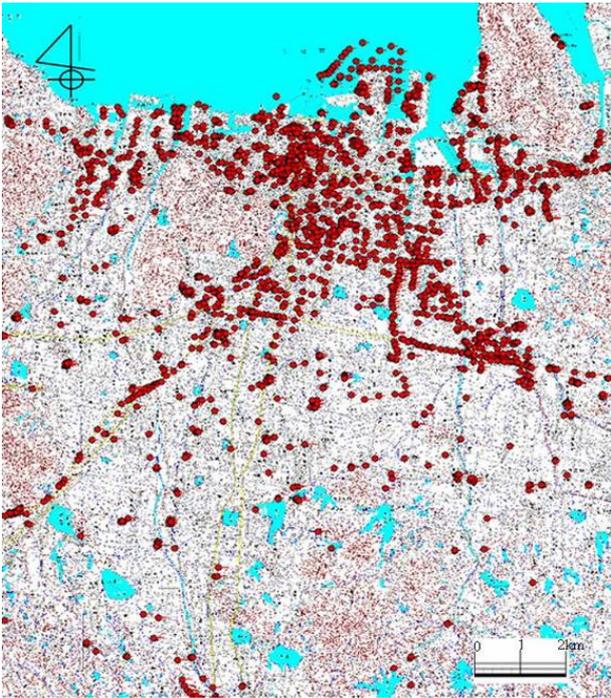
**Figure 9.** Locality of borehole logs in Takamatsu plain

Figure 9 shows the locality of borehole logs used to prepare database of Takamatsu area. Many borehole logs data are distributed around urban area and national highways include seashore. By the cooperation of public institutions such as Ministry of Land, Infrastructure and Transport and Takamatsu City Office, registered was possible to collect boring data have reached about 1,500.

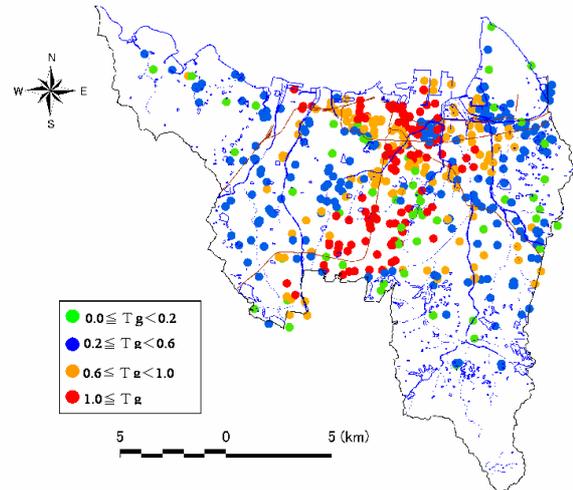
**Figure 10.** Distribution of predominant period in Takamatsu Plain

The microtremor has been observed at about 400 points in Takamatsu plain (Figures 10 and 11). The predominant period of the ground ( $T_g$ ) is estimated by the period of the maximum ratio of the H/V spectrum. The ground is divided into three types by the predominant period (Table 2).

Figure 10 suggests an interesting fact that long predominant period of the Koto River fan is originated from thick Quaternary sediments. Thickness of the Quaternary sediments coincides with borehole data.

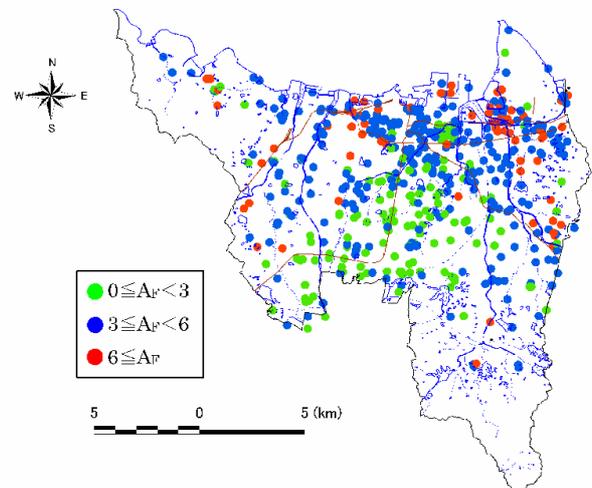
**Figure 11.** Distribution of amplification factor in Takamatsu Plain

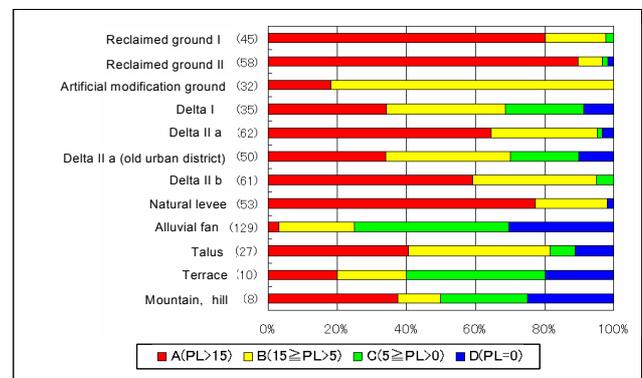
**Figure 12.** Liquefaction risk of micro-topographic zone

The liquefaction hazard map of Takamatsu city for the Type-I earthquake is shown in Figure 13. The study area is divided into grids of 200m in width. In the case of several borehole logs or result of different liquefaction risk estimation in grid, the highest  $P_L$ -value is adopted (Figure 12). The grids which do not have borehole log are considered as area of highest rate of liquefaction risk in each micro-topography. This map suggests that risk of liquefaction is very high at area like reclaimed land, delta in north of Takamatsu plain and flood plain along the Shin and Kasuga rivers.

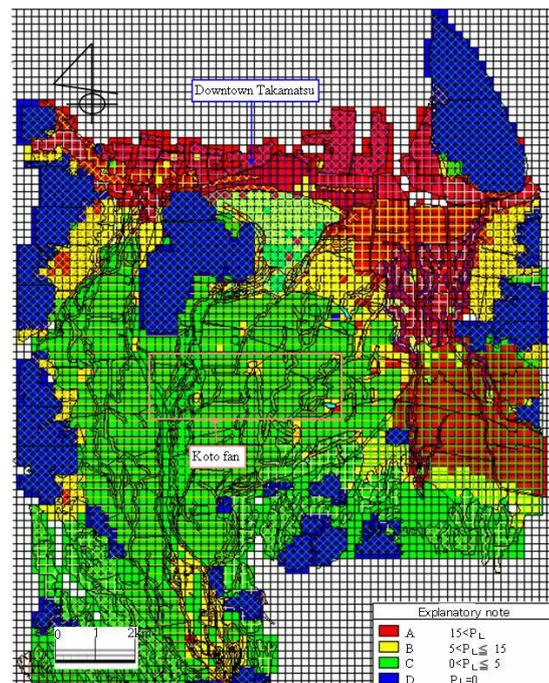
**Figure 13.** Liquefaction hazard map of Takamatsu city for the Type-I earthquake

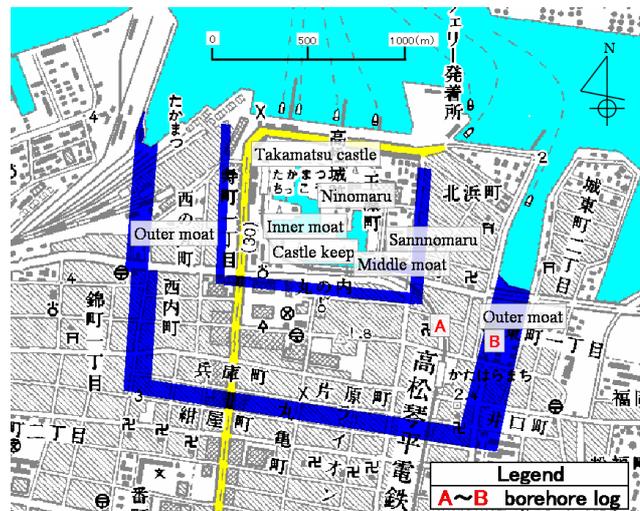
**Figure 14.** Locality of filled-up moats in the center of downtown area (Kagawa History Museum)

Local ground conditions are very important for estimating seismic hazards. At the center of downtown, old moats of Takamatsu castle had been filled-up and have been used for commercial area. Figure 14 shows the locality of filled-up moats from Kagawa History Museum. The borehole logs indicate that filled-up moats are very weak and can be liquefy easily (Figure 15).

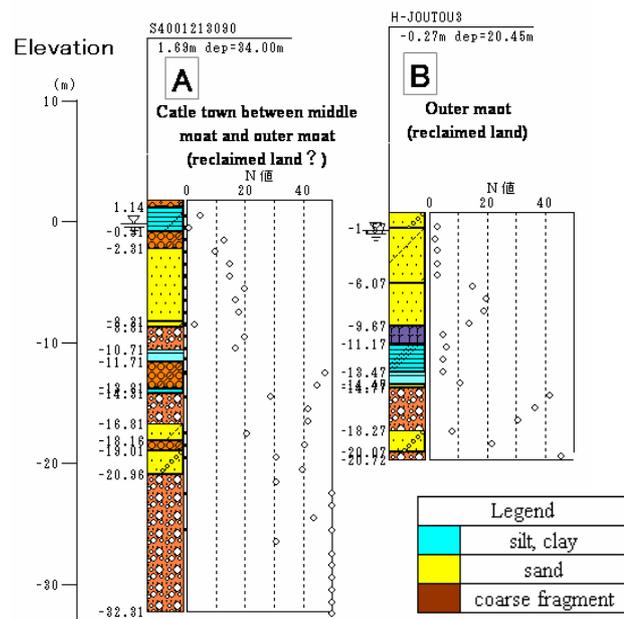
**Figure 15.** Borehole logs of filled-up moats in the center of downtown area
